Environmental Management Plan, Mutton Cove, SA

Environmental Management Plan

Mutton Cove, South Australia

17 December 2003

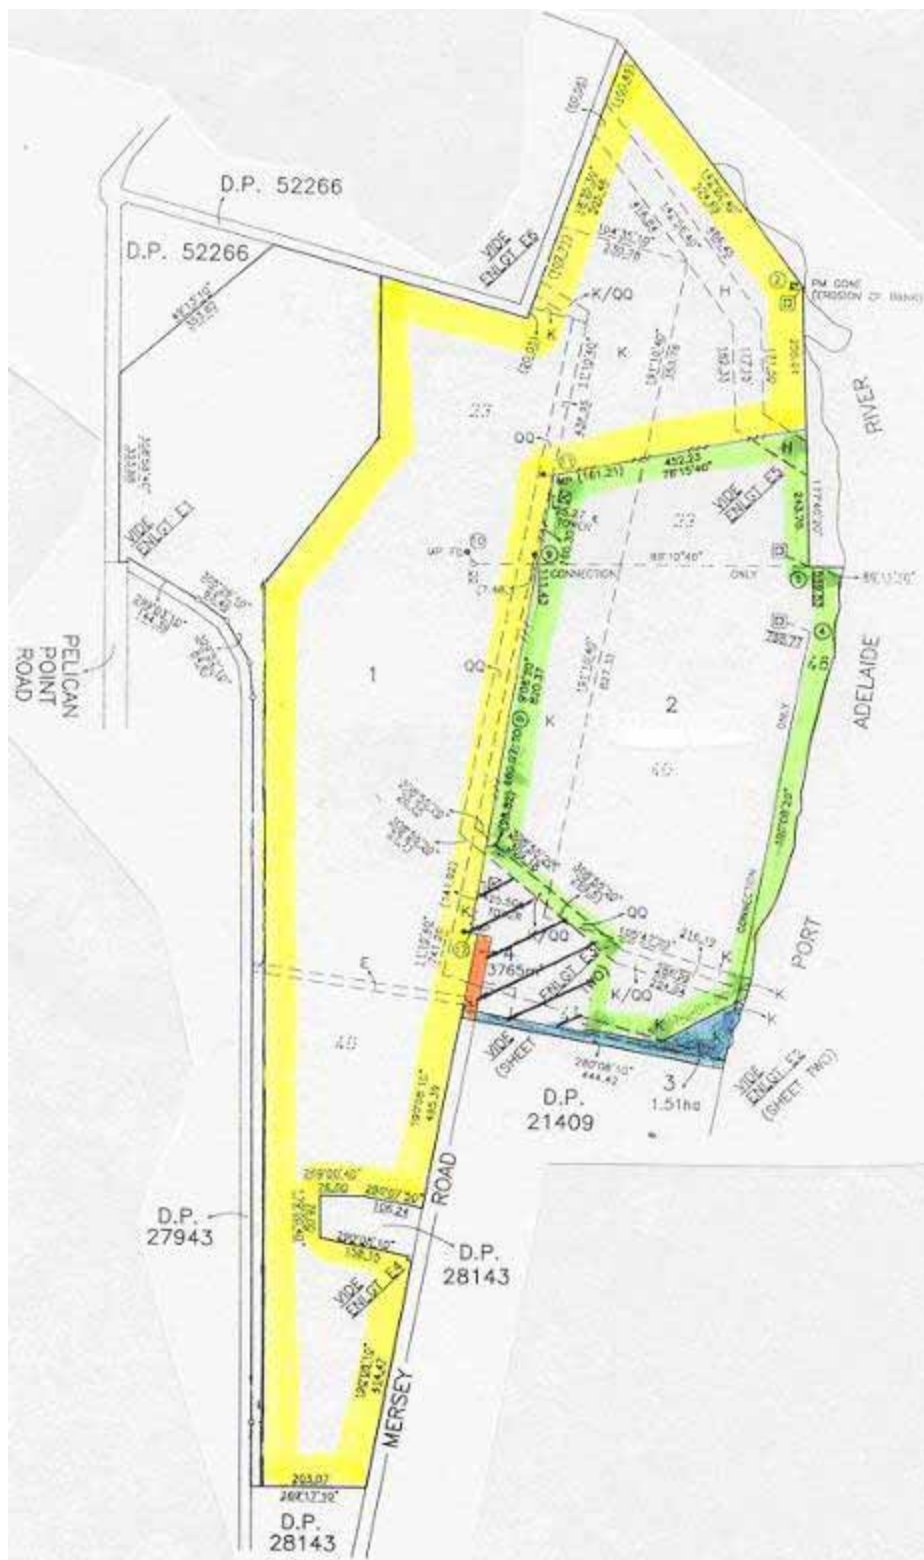
Figure 2 - Cadastral details of the Mutton Cove area

The land forming the Cove, marked “A” in Figure 2 is to be returned to the Crown as unallocated Crown Land and to be dedicated as a ‘Conservation Reserve’ under the care, control and management of the Minister for Environment and Conservation under Section 5(f1) of the Crown Lands Act, 1929.

Key:	Green:	Mutton Cove reserve boundary
	Yellow:	Balance of DEH land (Industry (Port) & General Industry (2))
	Blue:	Crown Land under care of MEC (Recreation & Car Park)
	Orange:	DEH land (future public road purposes)

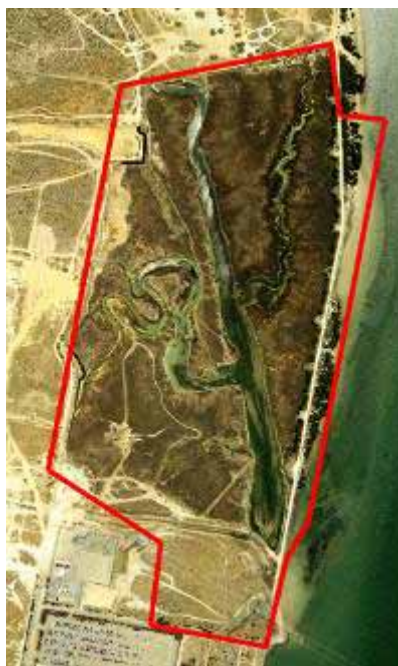
Figure 4 – Aerial photograph of Mutton Cove

Mutton Cove is in the Port Adelaide Enfield Council, less than 20km from the Adelaide CBD. The site is situated at the south-eastern border of the proposed grain terminal head-works on the Peninsula and just to the north of the Australian Submarine Corporation. The site boundary is outlined in red on Figure 4 shown below.

There are three branches of the Mutton Cove creek, as indicated in both Figures 4 and 5. The extent of these branches obviously extended beyond the proposed Mutton Cove area as shown in Figure 4. However, the outer limits of these branches have been blocked with earth levee banks and land fill. Currently no stormwater runoff actually enters Mutton Cove proper.

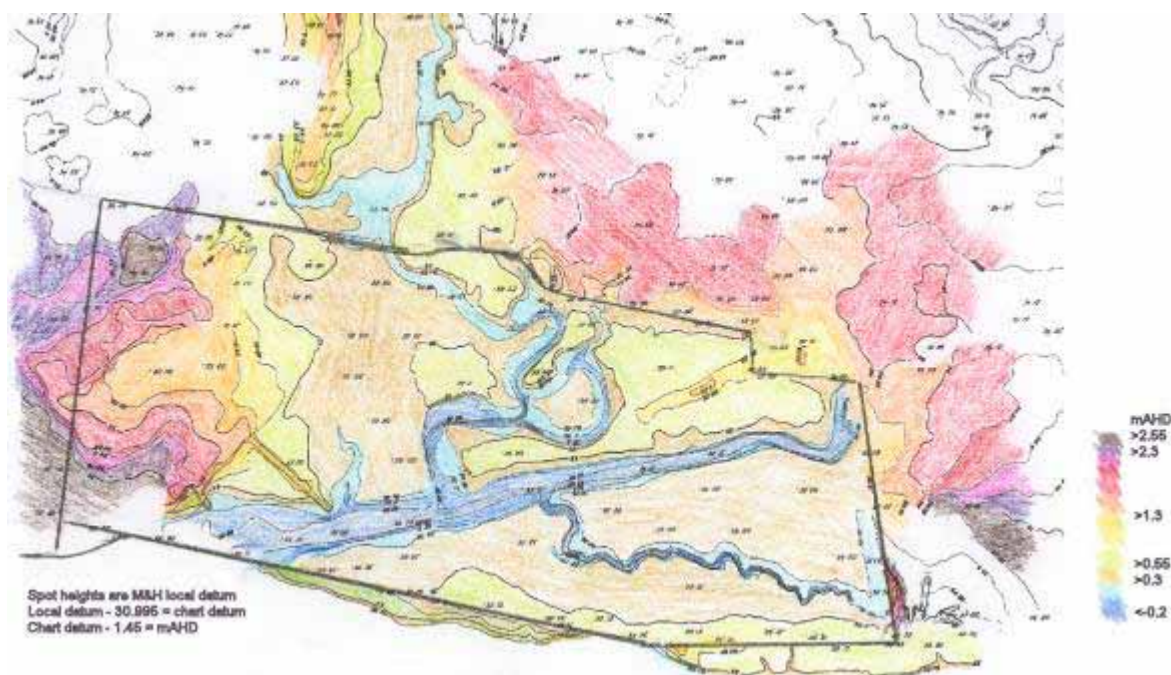
Figure 7 - Surface topography, Mutton Cove

The Department of Marine and Harbours flew aerial photography, combined with surveying spot levels, over the northern part of Le Fevre Peninsula in 1982 to establish land surface levels. Figure 7 is extracted from a map supplied from the archives of the Flinders Ports (Drawing 21994-30C), dated 1982. The levels on the map are presented as Marine & Harbours local datum, and have been converted to m AHD for the colour key, as stated in the figure. Ron Taylor of Flinders Ports, previously Marine & Harbours, supplied the diagram and the conversion details. The area of Mutton Cove is outlined.

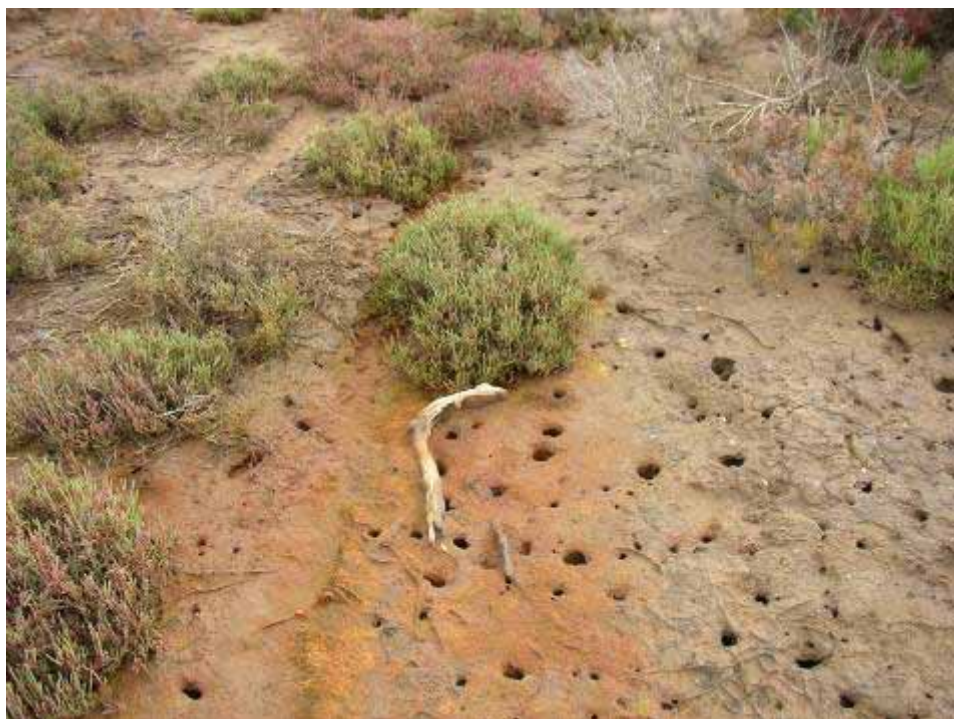
Figure 8 - Small patch of soil showing oxidised products

Typical effects of ASS in areas that have been cut off from tidal inundation include soil level subsidence as a result of oxidation of carbon (both organic carbon and carbonates) in the soil profile, as well as acidification of soils. Breakdown of soil structure may also occur in stranded saline clay soils as a result of Ca:Na exchange on the surface of clay particles, which results in the formation of sodic soils once freshwater rinses the chlorides (along with calcium) from the soil. It is likely that parts of Mutton Cove are, or have been, affected by ASS, and this will need to be considered during any construction or soil works. It is recommended that the guidelines provided by the Coast Protection Board in *Coastline 33* (CPB, 2003) be adhered to whenever earthworks are contemplated.

At Mutton Cove, there is evidence that the area has contained reactive ASS in the past, which has caused considerable sinkage, however only small patches of currently reactive areas have been observed.

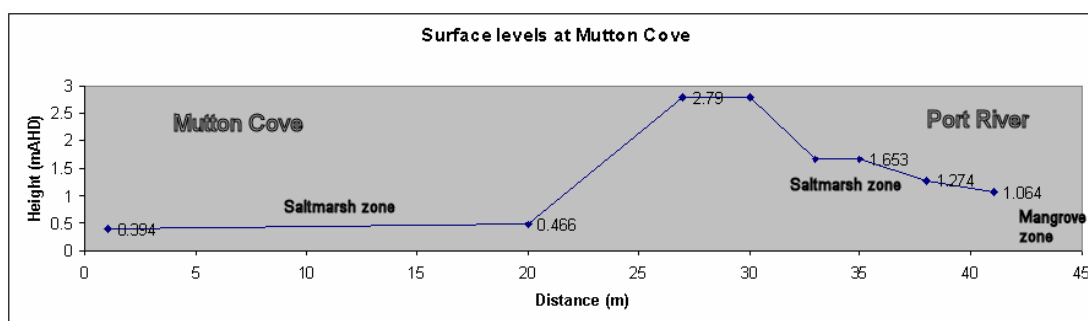
Figure 9 - Surface levels at Mutton Cove, across the seawall

The original vegetation of the area in early aerial photographs shows that Mutton Cove's vegetation was an ecotone between mangroves and saltmarsh. Observations of soil surface levels outside the Cove and in Barker Inlet show that the soil surface level for this ecotone is usually around 1m AHD. So, it would be reasonable to assume that the land surface across much of Mutton Cove prior to the placement of the seawall embankment would have also been approximately 1m AHD. At present, soil levels in the saltmarsh are between 0.4 and 0.55 m AHD, representing a reduction in level of over half a metre. A drawing showing the distribution of plant types at the different surface levels in Mutton Cove and in Barker Inlet is attached in the Appendices as *Mangrove and saltmarsh zonation*.

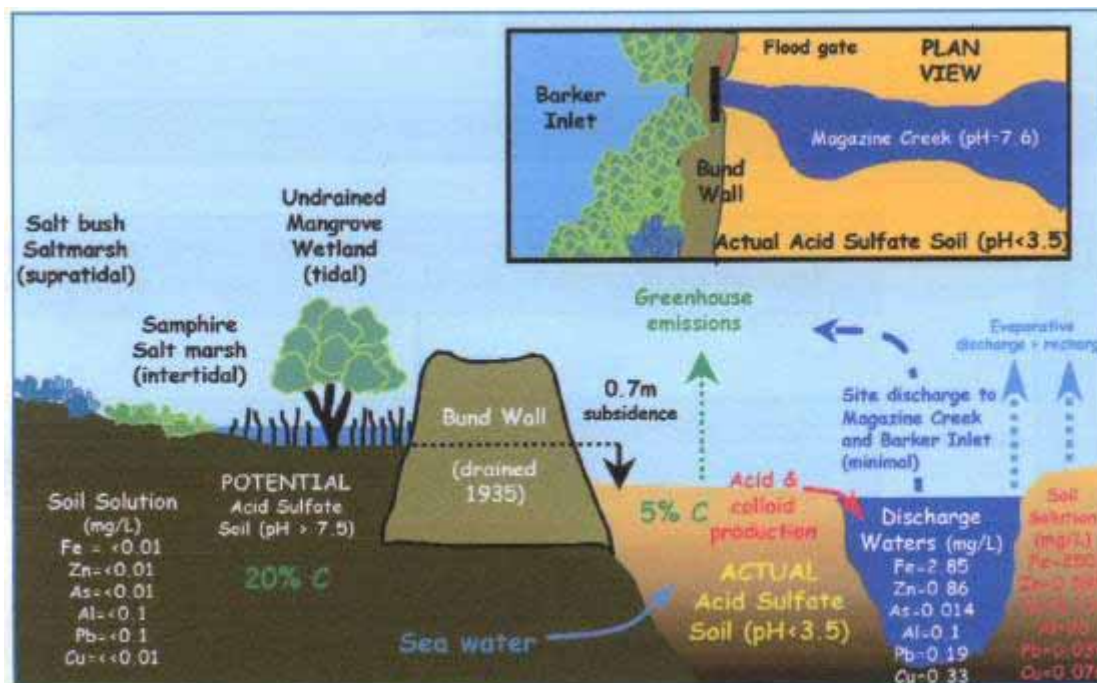
Figure 10 - Model of actual acid sulfate soil formation at Gillman (CPB, 2003)

This degree of land subsidence is not unusual in bunded saltmarsh areas. CSIRO recently undertook a study in the Gillman area, examining the acid sulfate soils that

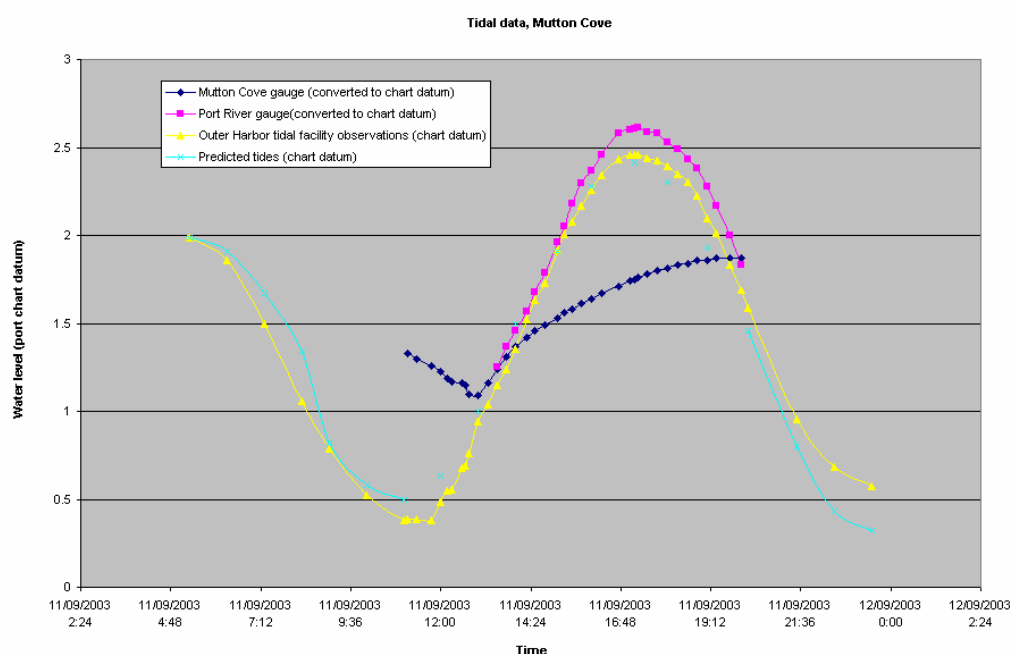
Figure 11 - Tidal data collected at Mutton Cove on 11 September 2003.

While one day of observations is a minimal data set, it is sufficient to provide an indication of the magnitude of the restriction and the time lag that is involved. For further reference, data were also obtained from the Outer Harbor tide station and from published tide predictions. The information has been plotted on the figure below, and the data attached in the Appendices as *Tidal restriction data*.

The graph shows that the predicted tide for the day reasonably closely matched the tide recorded at the official tidal station. In the Port River at Mutton Cove there was a lag of approximately 5 minutes, compared to the tide station. While the wind speed was low (around mid-tide) the tide staff in the river provided water level readings that were very similar to the readings at the tide station. However as the wind increased in the afternoon the water level in the river rose higher than at the tidal station – this is likely to be because the wind was pushing water into the narrowing river channel.

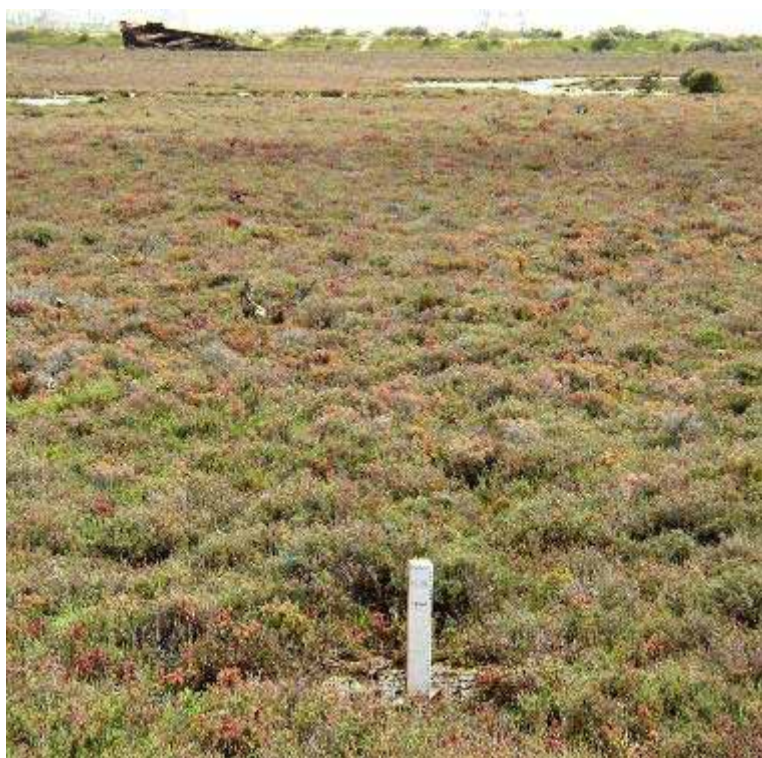
Figure 12 - Saltmarsh gauge at Mutton Cove

At each site, the level reached at the highest point of the tide was measured and recorded as mAHD. This was converted to chart datum by adding 1.45 metres to the AHD reading. This allows a comparison to be made with the tidal data provided by the Flinders Ports tidal station. From this comparison, the tidal height necessary to flood the saltmarsh at the ecotone was calculated for each site. In Barker Inlet, a tide of 2.4m chart datum will flood the ecotone, whereas in Mutton Cove (in September) inundation of the ecotone required a tide of at least 2.65m chart datum, due to the restrictions provided by the inlet pipes into the Cove.

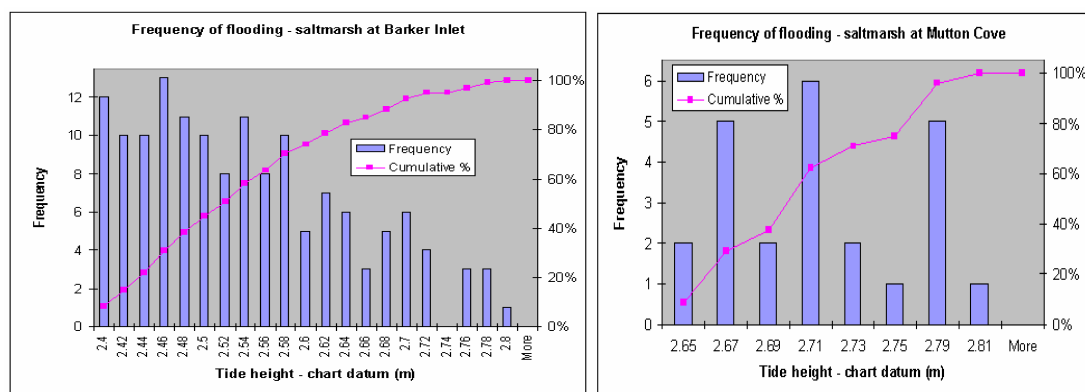
Figure 13 - Inundation regimes at Mutton Cove and Barker Inlet

Next, the tidal predictions for 2003-2004 were entered into a spreadsheet. The events that would cause inundation were isolated for each site, and histograms were produced for each location (see below). The data sets for these histograms are attached in the Appendices as *Inundation hydrology*.

The histograms reveal the magnitude of the difference in the inundation regimes. In Barker Inlet, the ecotone between mangroves and saltmarsh receives a fresh influx of tidal water on at least 146 occasions over the year. The maximum depth these inundations are predicted to reach is about 40 centimetres. As tide charts do not take into account the effect of storm surges, it is possible that the depth of water could be up to another metre deeper again during storm events.

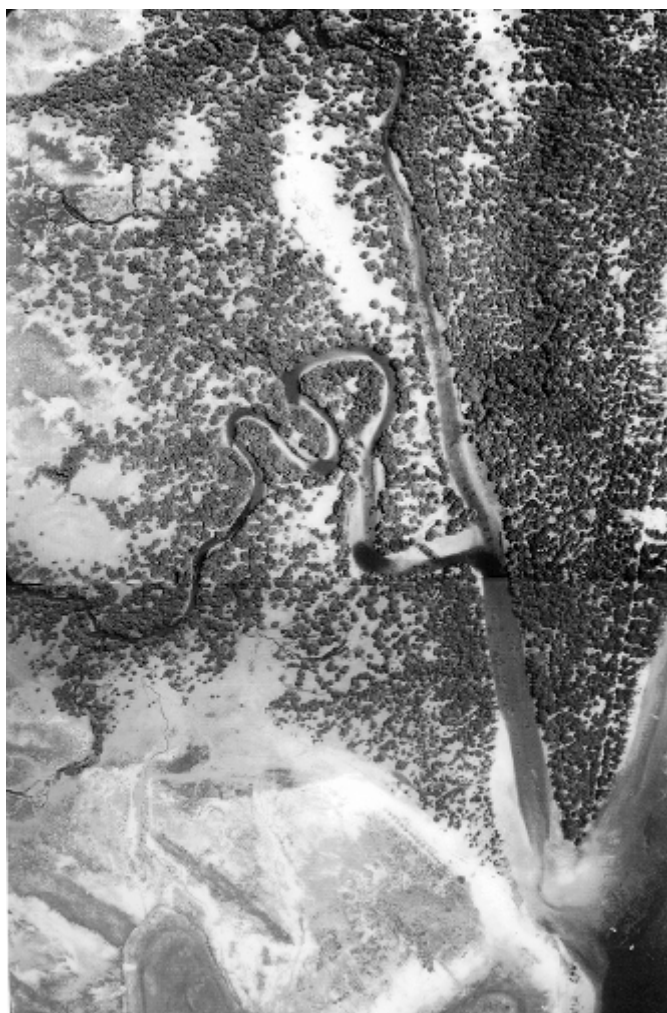
Figure 15 - 1963 aerial photograph of the Mutton Cove (copyright SA Gov't, Mapland)

Aerial photography dating from 1963 shows the historic vegetation of the area. In this photograph the area of the Cove appears to be an ecotone between the main mangrove forest along the foreshore and the intertidal saltmarsh and dune areas backing the mangroves. Such an ecotone is usually a very biologically diverse area, containing flora and fauna belonging to each of the adjacent habitats. In 1963 the site contained 44–49% mangroves, 5–6% tidal creeks with the remainder of the site comprising both intertidal saltmarsh and dune ridges (45–50%). The mangroves occurred in scattered clumps, containing only a few trees interspersed with samphires and saltbush.

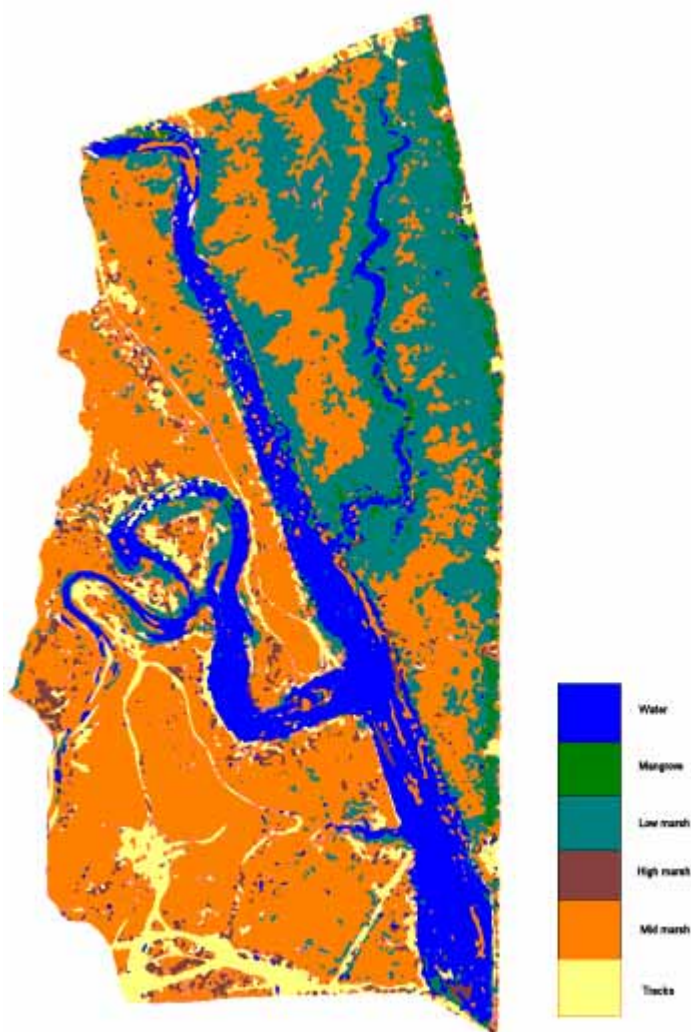
Figure 16 - Supervised classification of the tidal area of Mutton Cove.

Secondly, current aerial photography was run through both supervised and unsupervised image classification, so that each habitat type present in the area was clearly delineated.

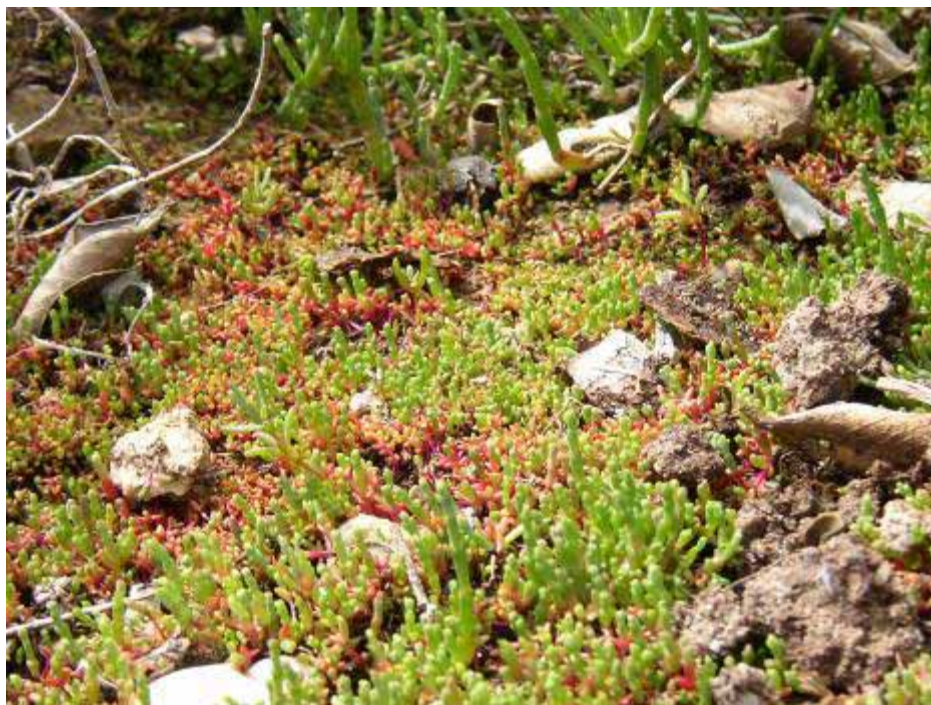
Figure 17 - *Sarcocornia* seedlings in the low marsh

The majority of Mutton Cove is saltmarsh. The low marsh supports a *Sarcocornia quinqueflora*, *Suaeda australis* low shrubland. Some of this area has evidence of mass recruitment of young *Sarcocornia*, probably a result of the increased inundation experienced since the first attempts to clear the pipes by hand, a few years ago.

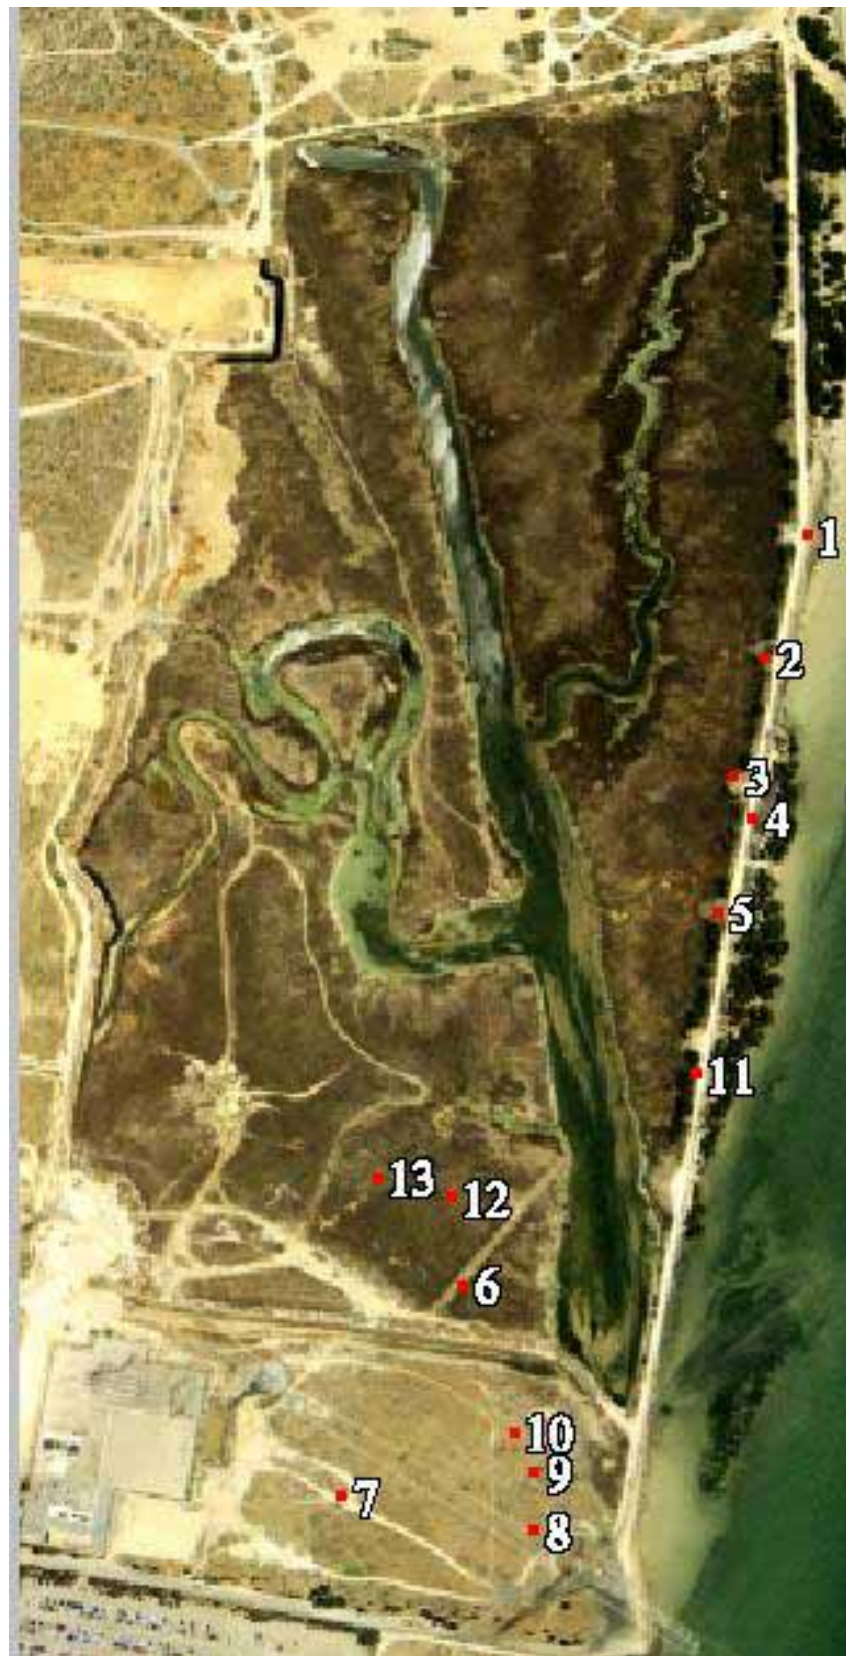
Figure 18 - Sampling locations in Mutton Cove

A sampling adequacy graph was constructed to ensure sufficient sampling of the site had been undertaken to provide a representative species list. A sampling adequacy graph was also constructed for native species only, showing that the later sampling locations, in the southern part of the Cove, contained mainly new weed species.

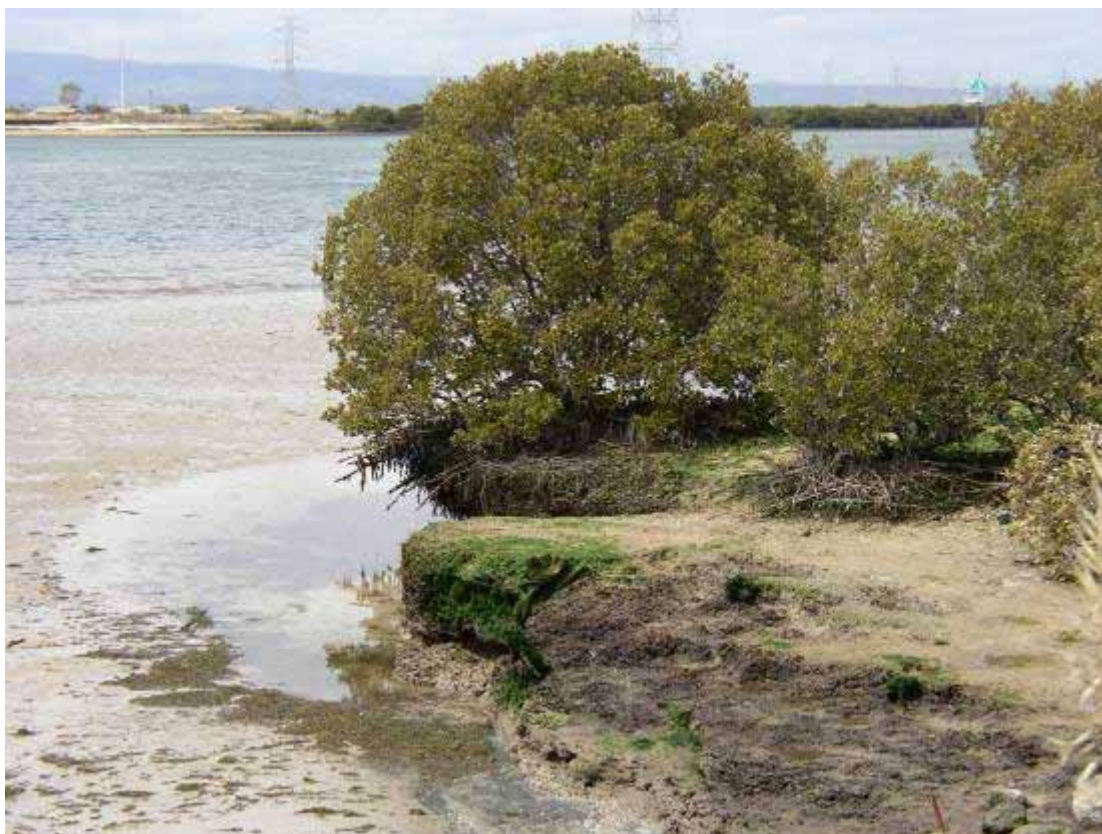
Figure 23 - Mangroves undercut from shipping wash

Loss of the protection provided by the mangroves will eventually cause an increase in the costs associated with maintaining the seawall. In other harbours where mangroves grow alongside shipping channels, a strict enforcement of speed limits has been found to reduce the impact somewhat.

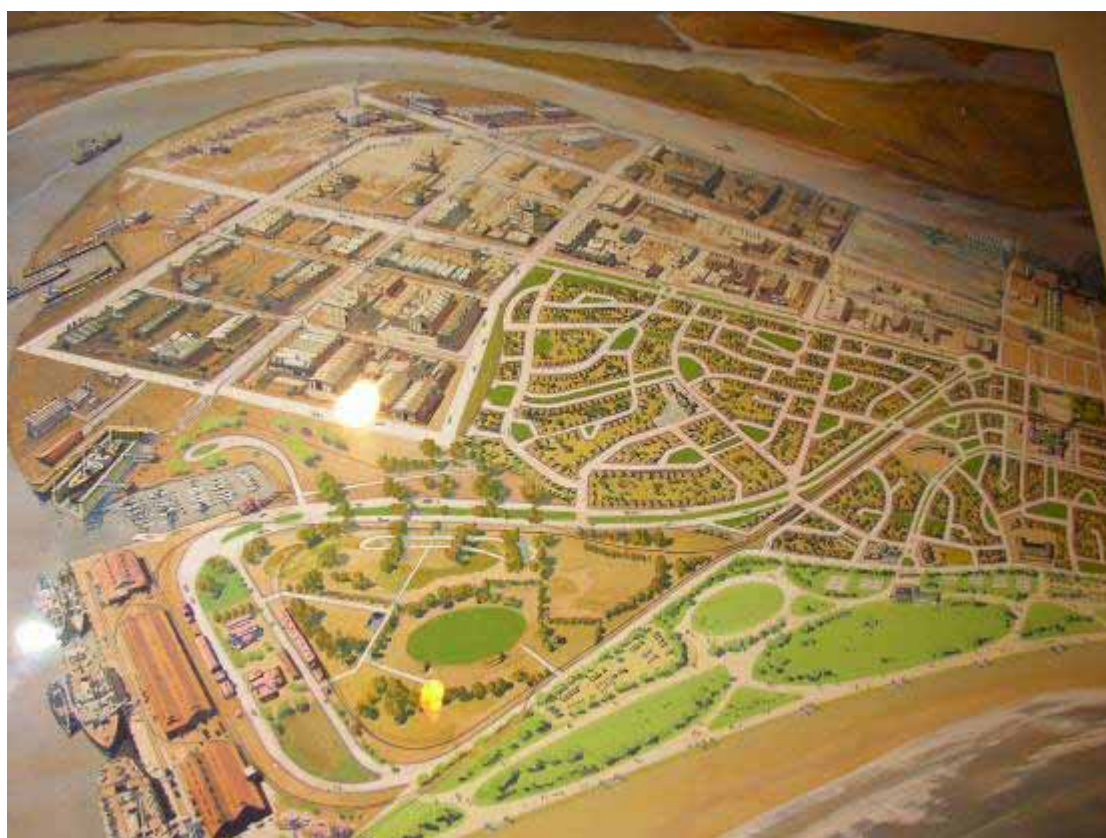
Figure 27 - The Greater Port Adelaide Plan (photograph courtesy the SA Maritime Museum)

The Greater Port Adelaide Plan was developed by the Department of Marine and Harbours in the 1960's. The photograph, reproduced here, of the proposed development of the tip of the Peninsula shows the region to be fully filled, with Port activities covering all the land fronting the water. Mutton Cove appears as an area of warehouses. To realise this development would require a considerable quantity of both fill and seawalls, and an immediate start was made on raising the land surface to a level that would enable the development to occur.

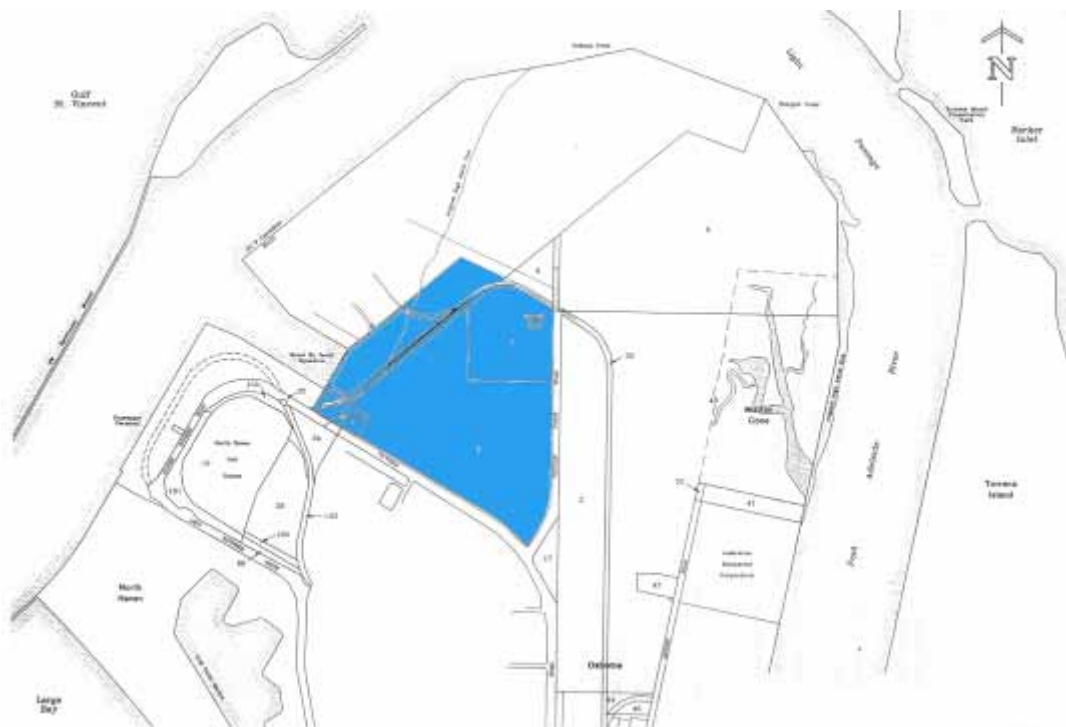
Figure 29 - Area studied in Maunsell Outer Harbour Study (coloured blue)

The site examined in the report is the area surrounding the current location of the aquaculture farm. It is a 65 ha block, bounded by Pelican Point Road on the East and Coghlan Road to the West. The study site included the western portion of Biodiversity Park and some of the area around the park. The site contains areas of hydraulic fill and organic layers (1970’s), calcareous sand overlying stiff sandy clay at approximately –10m AHD, caustic grits and cinders.

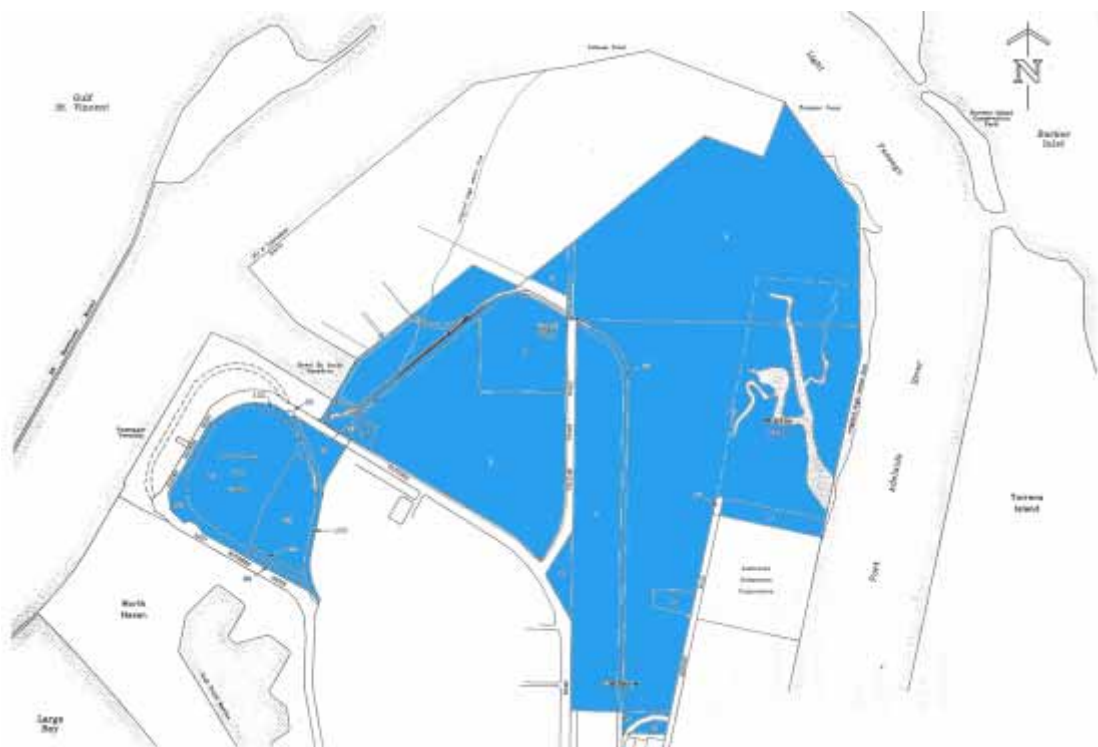
Figure 30 - Maunsell study area for the Pelican Point core site

The report documents the soil and groundwater monitoring results obtained from the site in 1995. The results show gross petroleum contamination of the area where the Amoco terminal was, to the point where working on the site was considered hazardous, particularly construction works with welders and other spark-producing equipment. The northern triangle of Biodiversity Park (next to the aquaculture farm) was found to have moderate contamination with heavy metals, rendering some of it unsuitable for use as a park, but still suitable for industrial use.

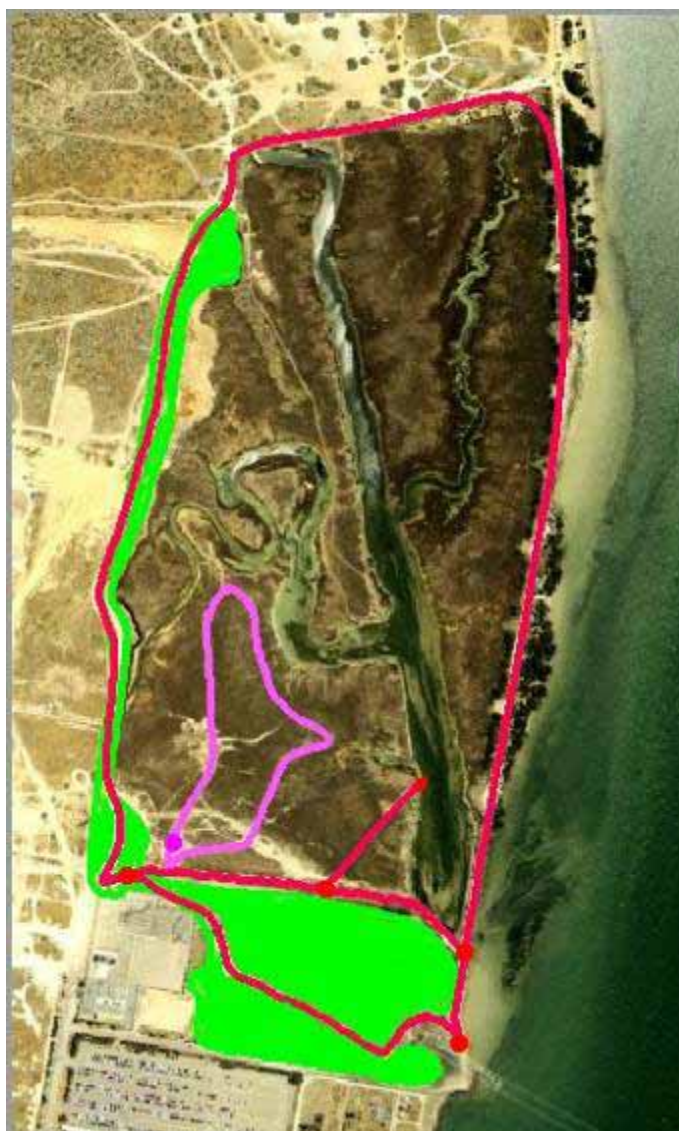
Figure 35 - Map of track rationalisation and revegetation areas

Tracks through the samphire should be rationalised to the main tracks only, and the chosen tracks could be raised slightly and gravelled. This will make them accessible during the wetter times of the year and the cleaner, drier surface will tend to discourage people from leaving the track. Careful loosening of the soil at the accessible ends of tracks chosen for closure will allow saltmarsh species to recolonise these areas. The remaining portions of track will then revegetate over time, as the track is no longer trampled. The diagram of proposed track rationalisation (Figure 35) shows high priority paths in red, lower priority paths in pink, and revegetation areas shaded with green.

The seawall embankment requires a small amount of fill to remove surface pot-holes and make the walking surface safer. Occasionally the river-side of the seawall will require some rocking to repair erosion.

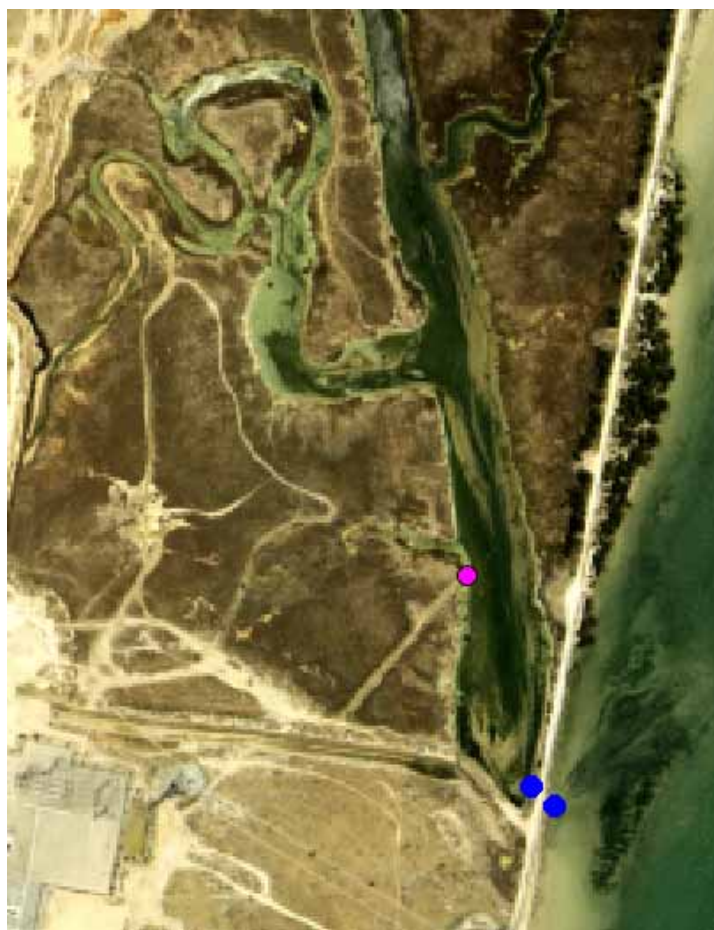
Figure 36 - Sample site locations.

The proposed permanent water quality monitoring site is shown as a pink dot in the aerial photograph given below. The current locations (to be retained for tidal monitoring) are shown as blue dots.

Once further sediment has eroded, a suitable location for water quality sampling may be a small landing or jetty built at the end of the low embankment which runs semi-perpendicular to the Cove. The end of this would need to be in water most of the time, with sufficient depth to occasionally monitor water clarity (2-5m). Measuring this parameter is currently impractical at the inlet basin.

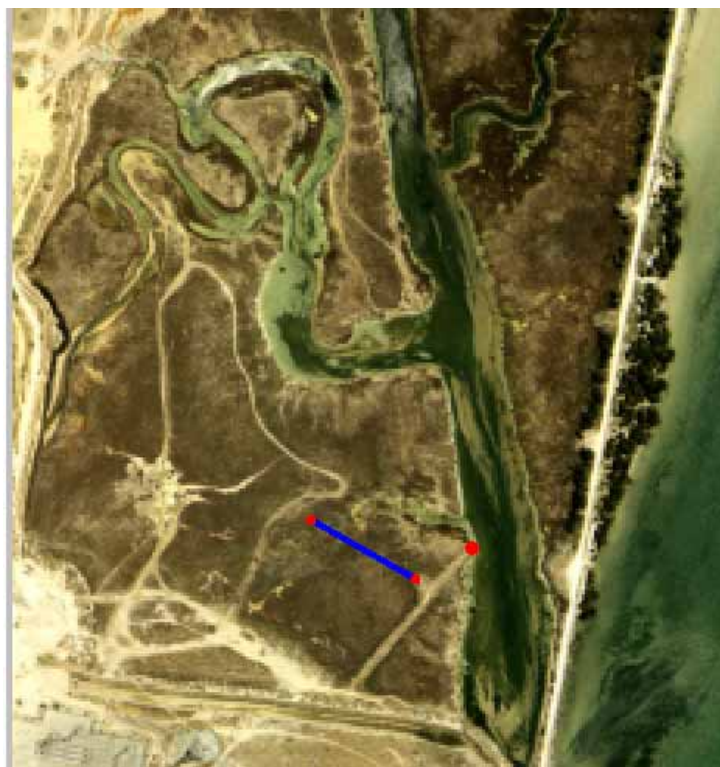
Figure 37 - Map of transect and photo point locations.

A photo point has been placed at the end of the perpendicular embankment, looking northwest along the Cove. The location for the photopoint is shown on the aerial photograph in Figure 37. A wooden stake has been driven into the ground where it can be seen in the photographs; with a known amount protruding above the ground (1m). This will provide a scale in the photographs. Another short stake has been driven into the embankment so that a camera may be placed on top of it. These stakes will need painting occasionally to prevent deterioration.

A 100m transect has been set up in the southern samphires, and its location is marked in Figure 37. These have been surveyed, and the beginning and end points have been marked with wooden pegs and orange tags. The start peg is on the embankment (0272151E, 06148603E, Australian Map Grid), and the end point is not far from the tracks left by off-road vehicles (0272229E, 6148556N).
