St Kilda Bay

Restoration options

PSJ Coleman and FS Cook

20 March 2003

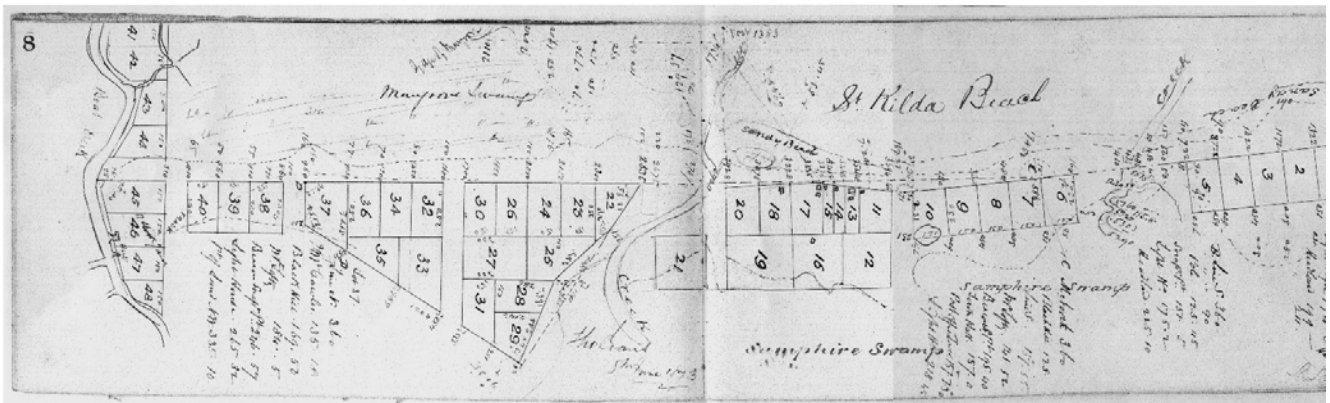
Figure 1 - Pages 8 & 9 from Survey Field Book 662 (Evans, 1873)

These details are shown in Survey Field Book 662 lodged in the Lands Titles Office and drawn by Thomas Evans in 1873. One of the pages from Thomas Evans field book is reproduced over the page, showing an overview of the township. The other pages, and reproductions of historic mapping, have been provided to the Progress Association as reference materials.

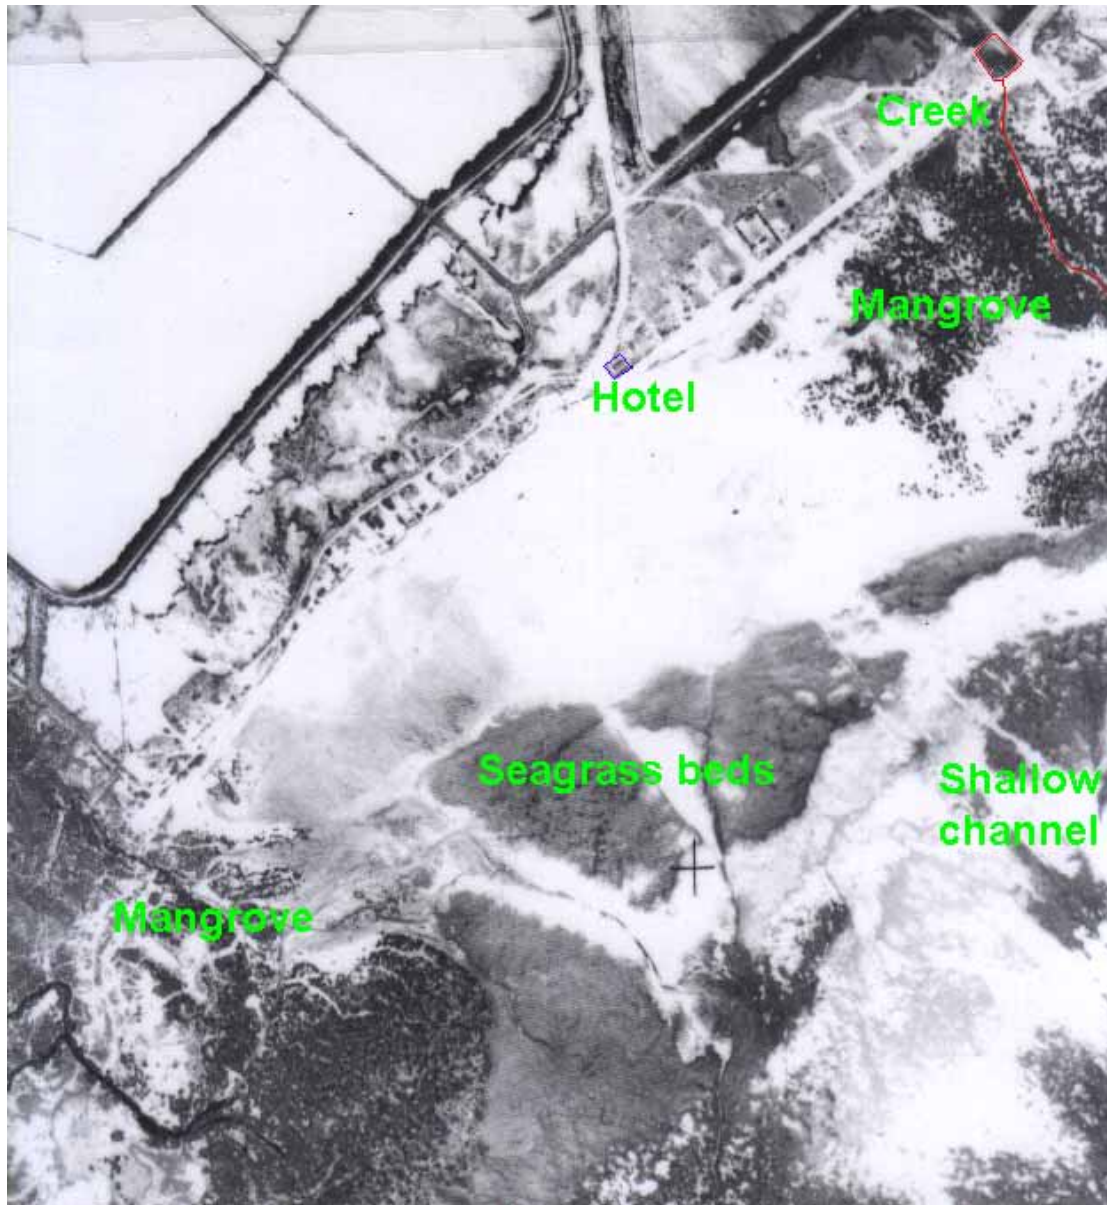
Figure 3 - St Kilda Bay, 1949

The 1949 photograph shows the mangroves growing in front of houses south of the hotel, and the deep, mangrove-lined creek where the boat channel is presently. The shallow boat channel came in to the hotel, and was used by limited draught boats at high tide. There were well-established seagrass beds just off-shore that came as close to the shore as the landward edge of the adjacent mangroves.

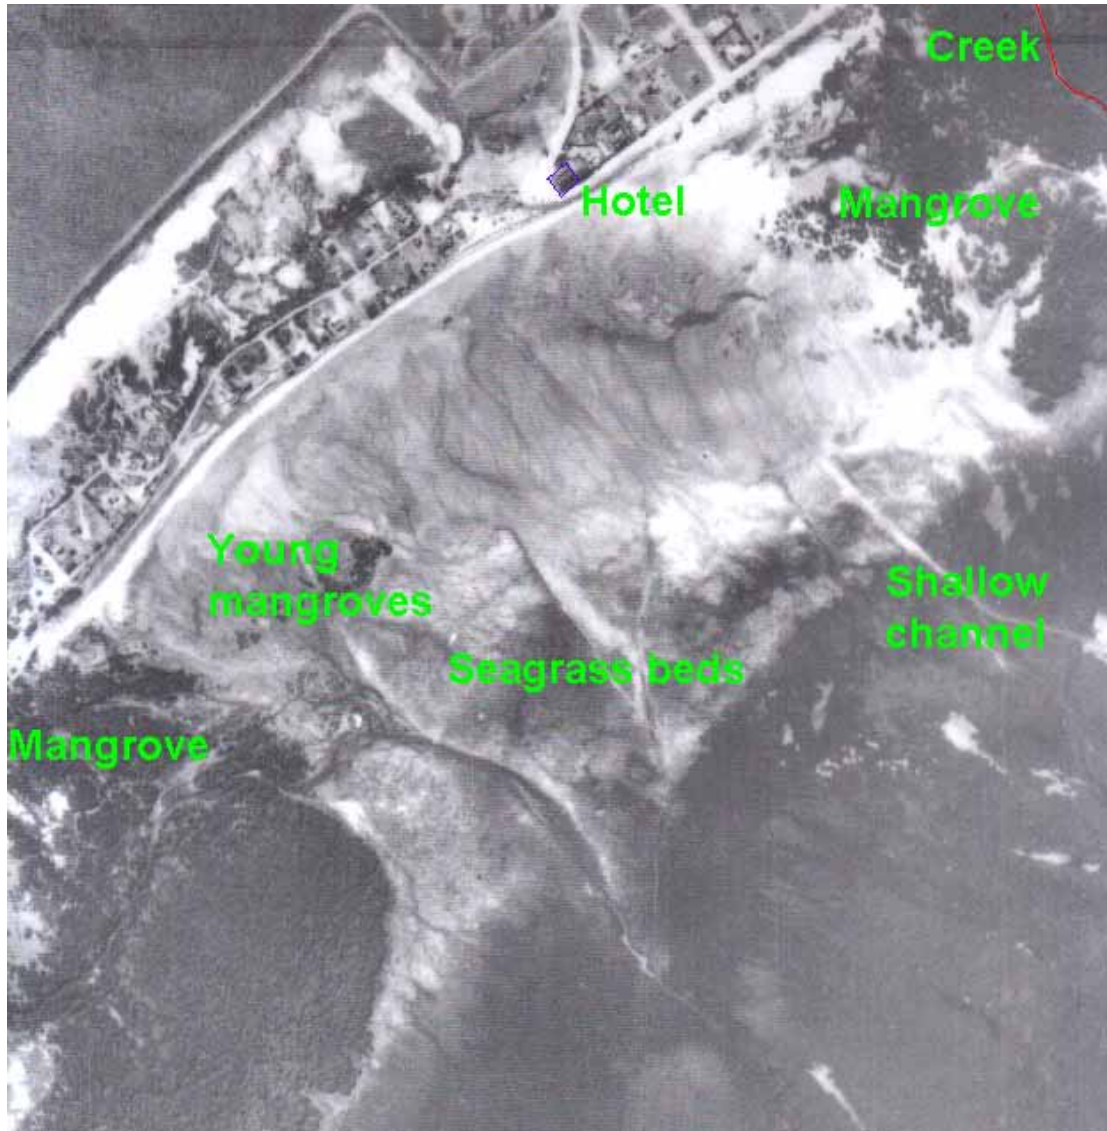
Figure 4 - St Kilda Bay, 1961

Not a lot had changed by 1961. The photograph from that year shows a very similar landscape to that of 1949. The seawall around the hotel had been improved. This was probably done in about 1950 as it can be seen in the photograph of the hotel in Figure 2.

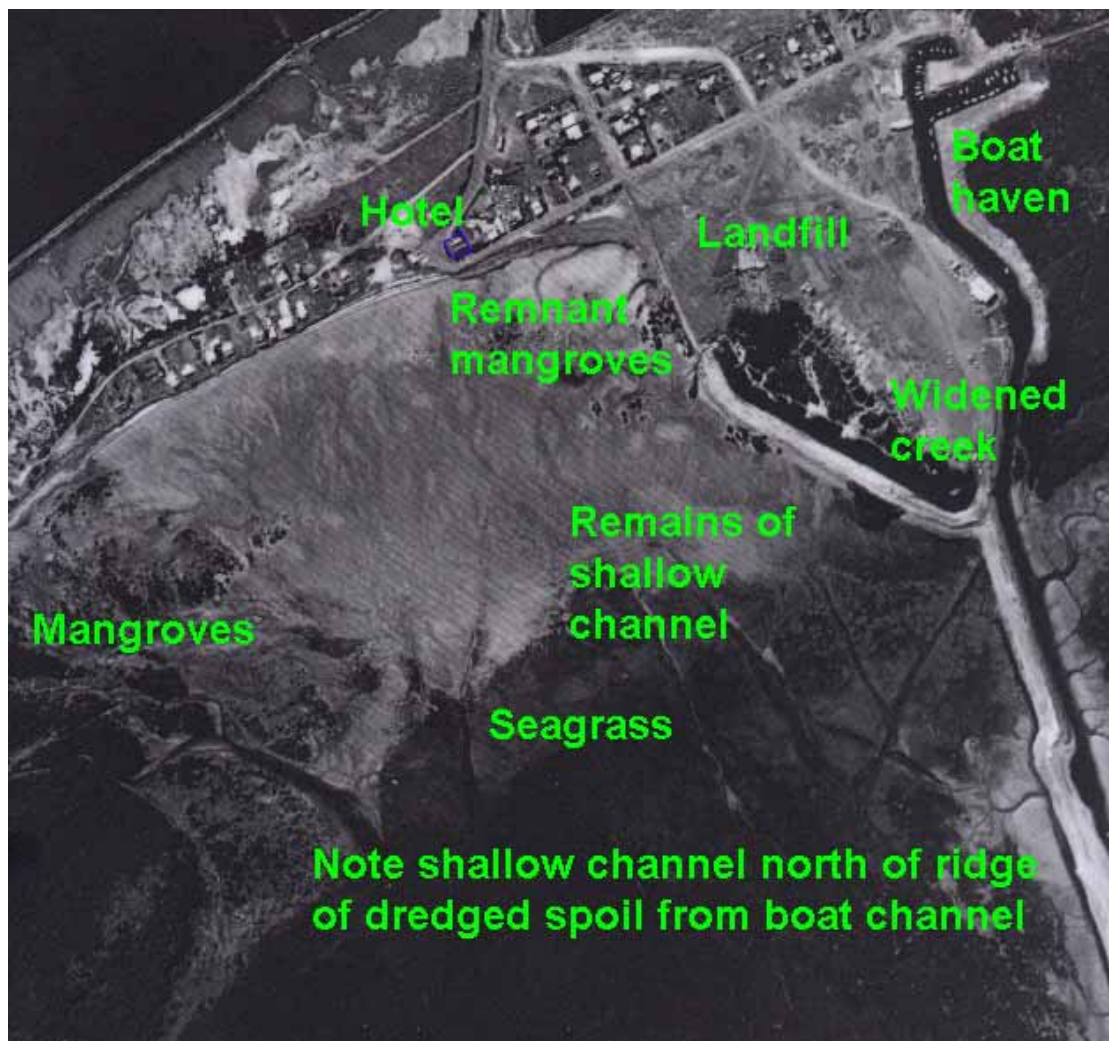
Figure 5 - St Kilda Bay, 1972

A shallow channel established itself north of the dumped spoil. It may have been kept open by water being pumped out of the landfill area, where a deep collection area existed just behind the seawall. This channel and the collection area can be seen in Figure 5.

By 1972 the Bolivar Wastewater Treatment Works had been operating for seven years, and this, combined with the dredging and landfilling activities, may explain the dieback of seagrass, compared to 1961, that is visible in the photograph.

Some of the proposed channel has existed at various times in the past (see the 1972 aerial photograph, earlier in this report), and so cleaning it out may possibly be considered a maintenance activity. Whether an activity is considered to be maintenance or a new development will have implications on the types of planning approvals that may be required.

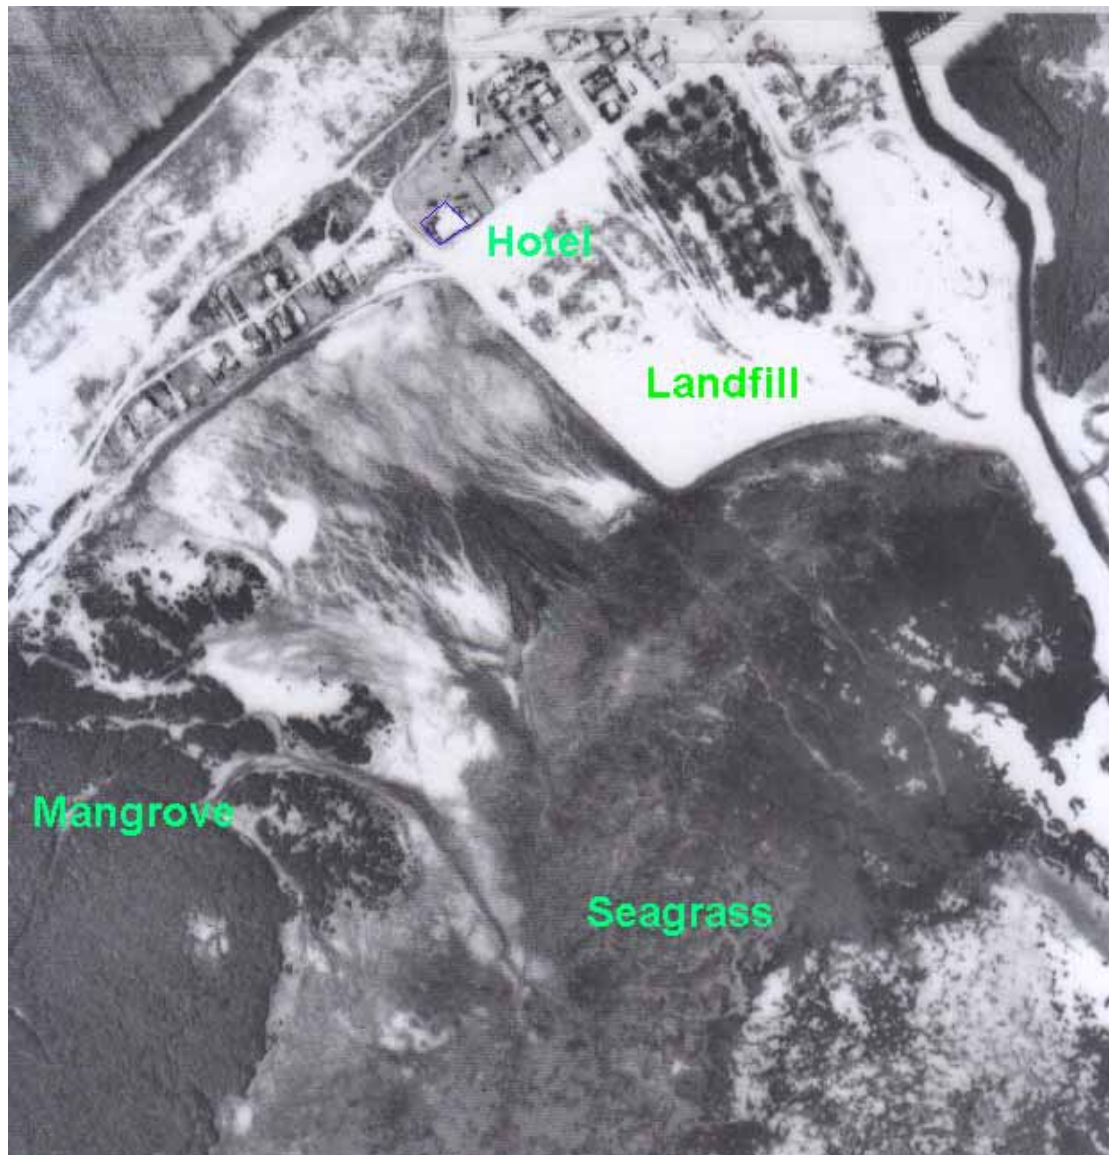
Figure 6 - St Kilda Bay, 1979

A photograph taken only seven years later in 1979 (Figure 6) shows how quickly the landfill progressed. An additional 'cell' had been added on the northern side of the landfill and now completely covered the mangrove forest, except of two small, isolated trees.

The photograph from 1979 clearly shows plantings and other improvements taking place on the southern cells of the landfill. There appears to be no further pumping out occurring at the landfill, and the channel to the immediate north of the boat channel dredge spoil embankment has filled in. The shallow channel to the hotel has almost disappeared.

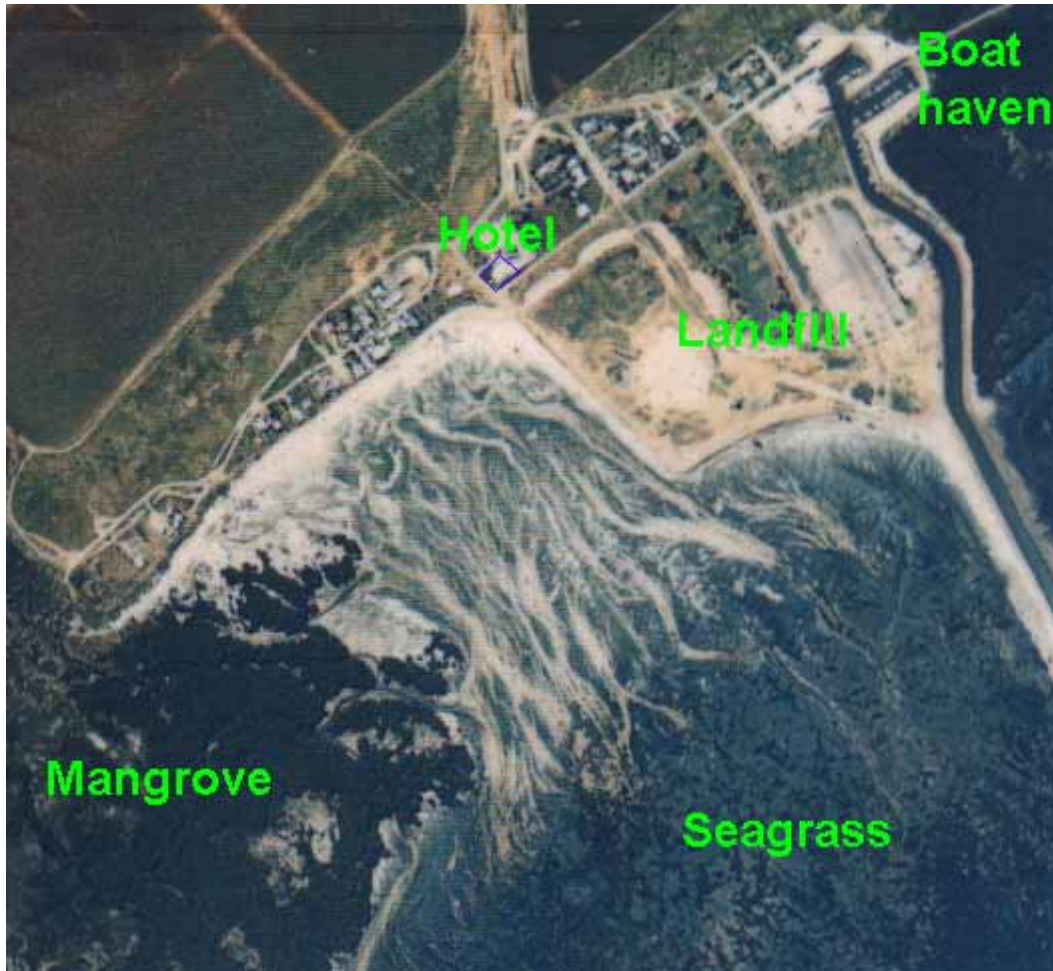
Figure 7 - St Kilda Bay, 1989

Figure 7 shows the view in 1989. It is likely that the gas pipeline was installed by this time and the lumpy dredge spoil north of the boat channel would have been 'rocked' to prevent it slumping and to make a firm foundation for the pipeline.

seagrass beds had deteriorated into separate little 'islands' with patches of bare sand between them.

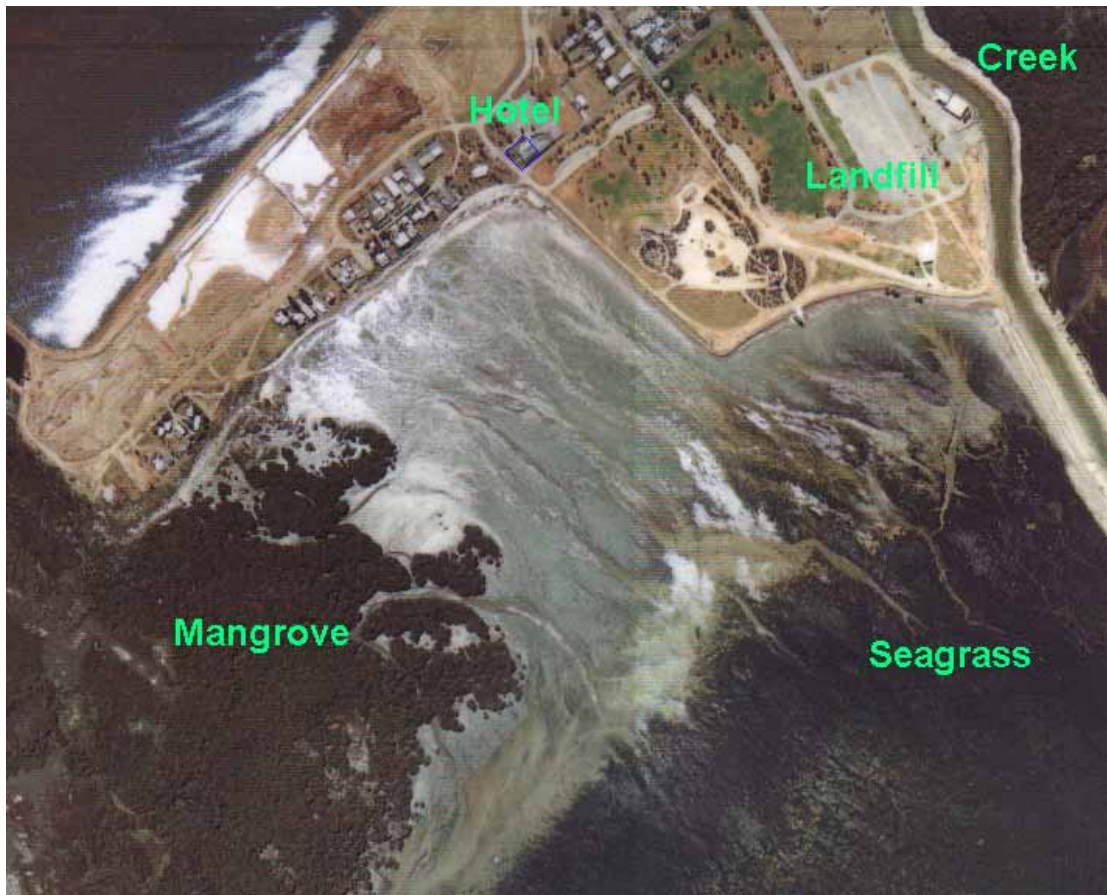
Figure 8 - St Kilda Bay, 2000

The final photograph in the series shows the bay in 2000. The boat channel was being dredged again in this photograph, and a series of holding ponds on Whiting Street Common holds the dredge spoil. The water flow from the dredge spoil ponds passes through several holding ponds prior to discharge to sea through the drainage system at the south and through the samphire creek north of the last houses.

What can also be seen in this last photograph is that the rapid retreat of the seagrasses is still continuing. One of the most recent areas of seagrass to die back was a patch just off the end of the playground (built on the old landfill). The rusty colour on the photograph marks the area that had recently died. Within a few years the area will simply look bare, as the rest of the bay does.

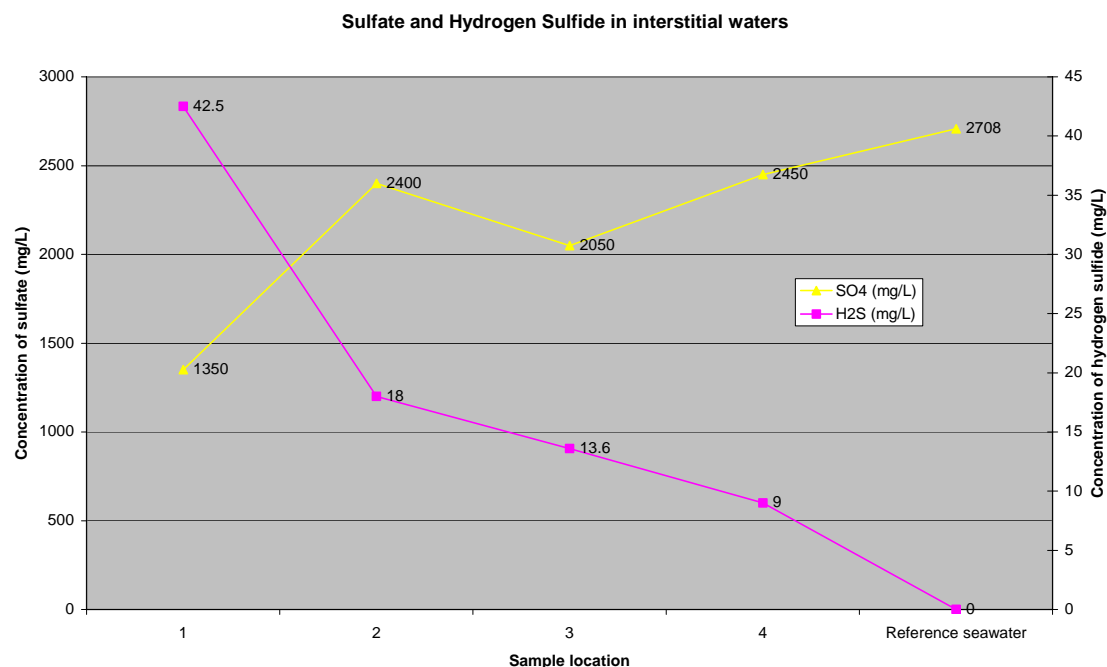
Figure 9 - Graphical representation of sulfate and hydrogen sulfide concentrations

Bacteria are responsible for converting the sulfates available in seawater into hydrogen sulfide. Section 6.3 contains information on this process.

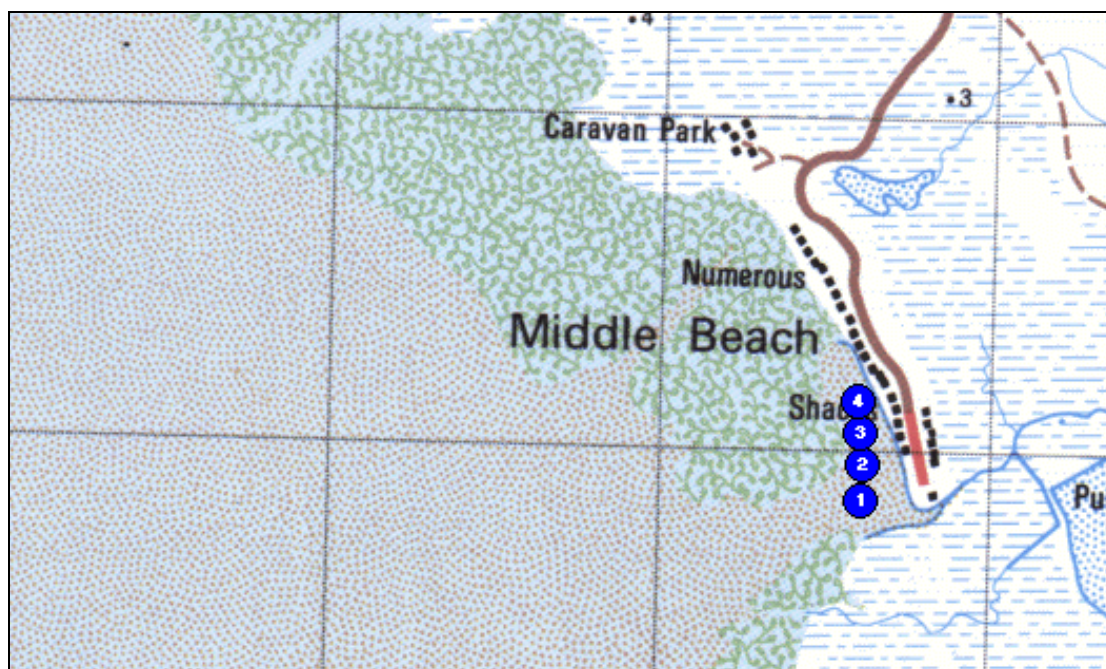
Figure 10 - Middle Beach sampling locations

Sites 1-14 had mud cores and water samples collected from them. Site 15 at St Kilda was in the mid to upper littoral zone (higher and drier than the rest of the bay) and the sample holes there were dry, so no samples were collected from that site. Other observations were made, however.

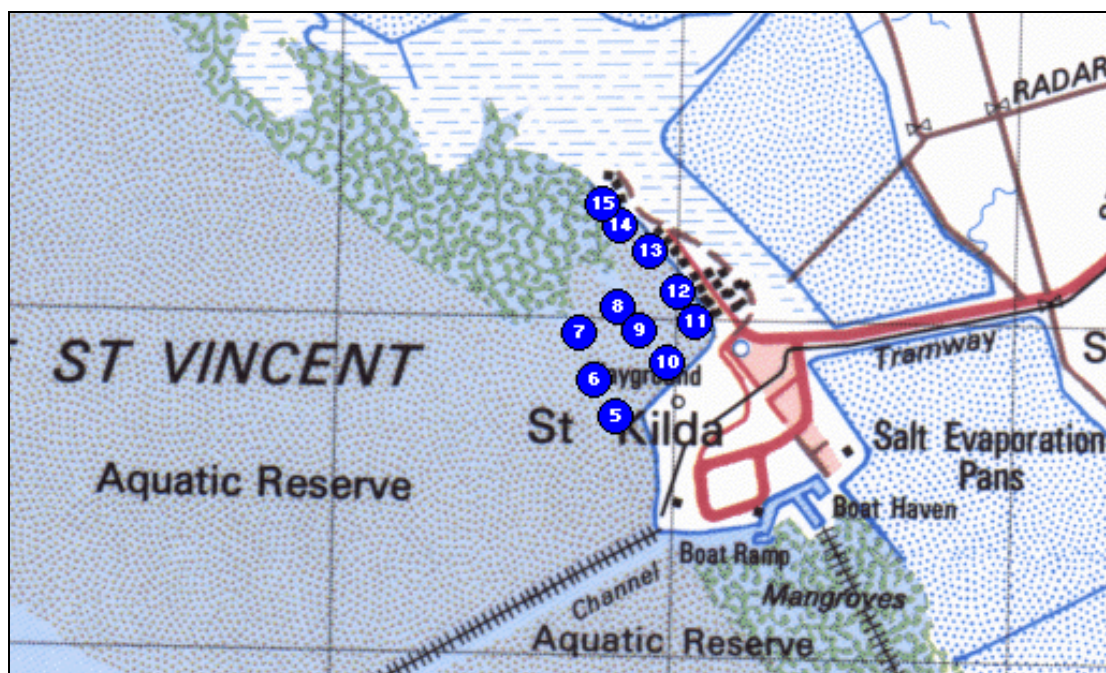
Figure 11 - St Kilda sampling locations

An aerial photograph with detailed locations sampled at St Kilda is provided in Appendix 1. The sites have very similar topography and also similar vegetation associations, as can be seen on the two following figures, extracted from the Coastal Atlas of SA (DEH, 2003).

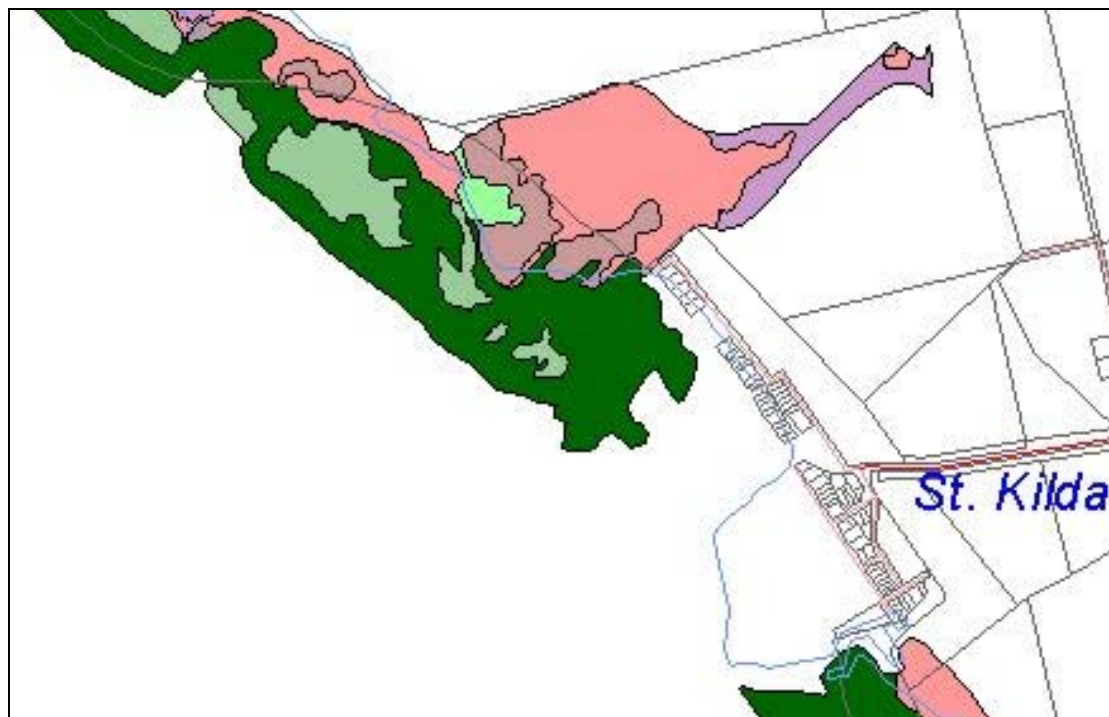
Figure 12 - St Kilda vegetation associations (DEH Coastal Atlas of SA, 2003)

The two sites both have southern creeklines, a band of mangroves on the seaward side of the beach area (dark green, containing new areas coloured apple green and dying areas coloured

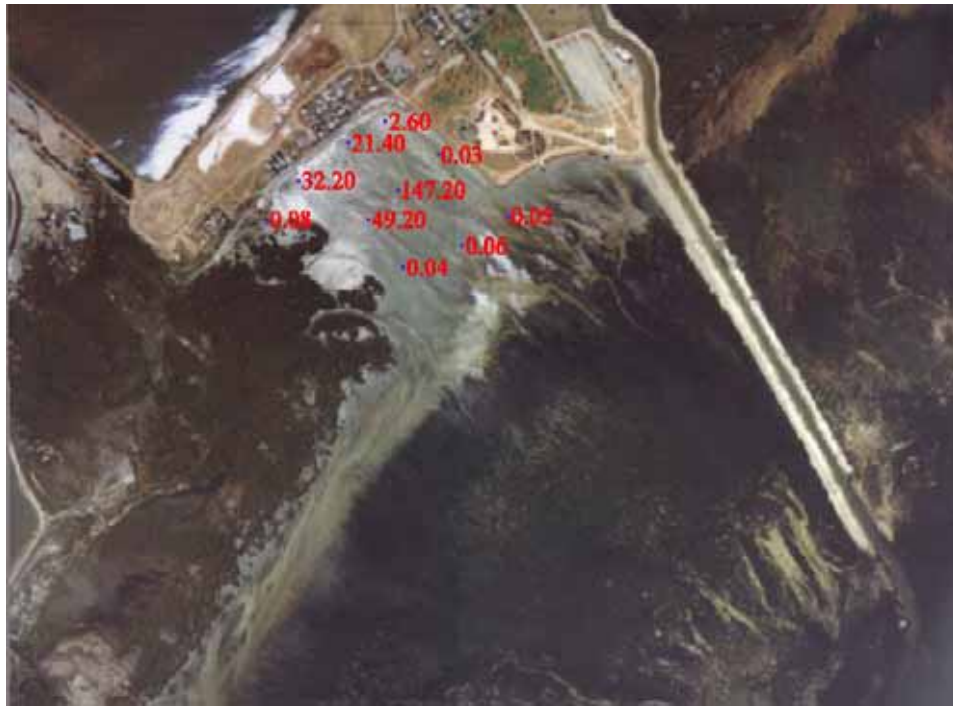
Figure 14 - Hydrogen sulfide concentrations in the mud at St Kilda

Similarly, the pH varied considerably, and was lowest (most acidic) at St Kilda. Normal seawater has a pH of approximately 8.2, and a reduction of that suggests that anaerobia or acidic pollutants may be present. When sampling sediments, the pH usually falls a little, in the zone where little oxygen is present.

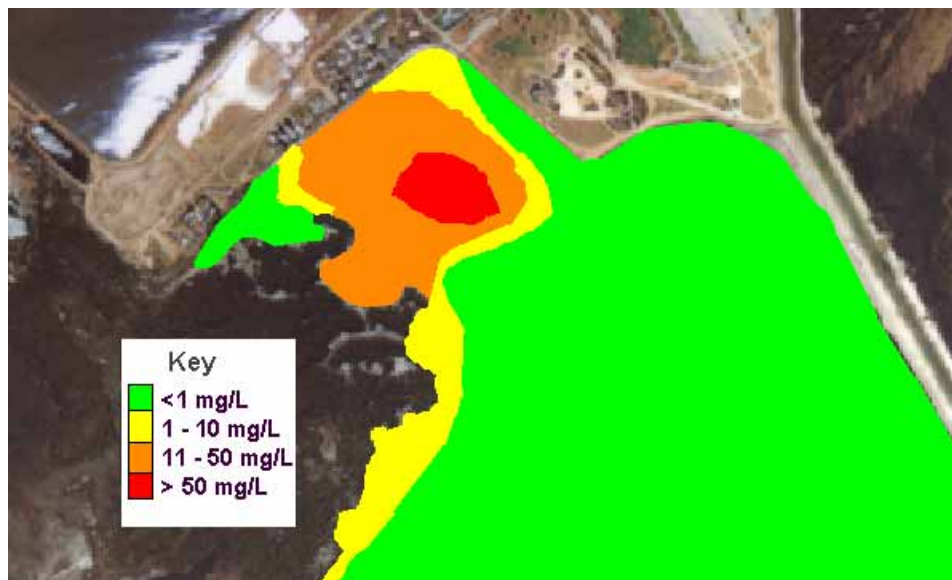
Figure 15 - Approximate distribution of hydrogen sulfide concentration

The concentrations obtained at each site can be generalized to a degree, to gain an idea of what pattern of sulfide concentrations are present across the bay. The figure above attempts

this, although the limited number of data points would suggest that the locations of each band may not be totally accurate.

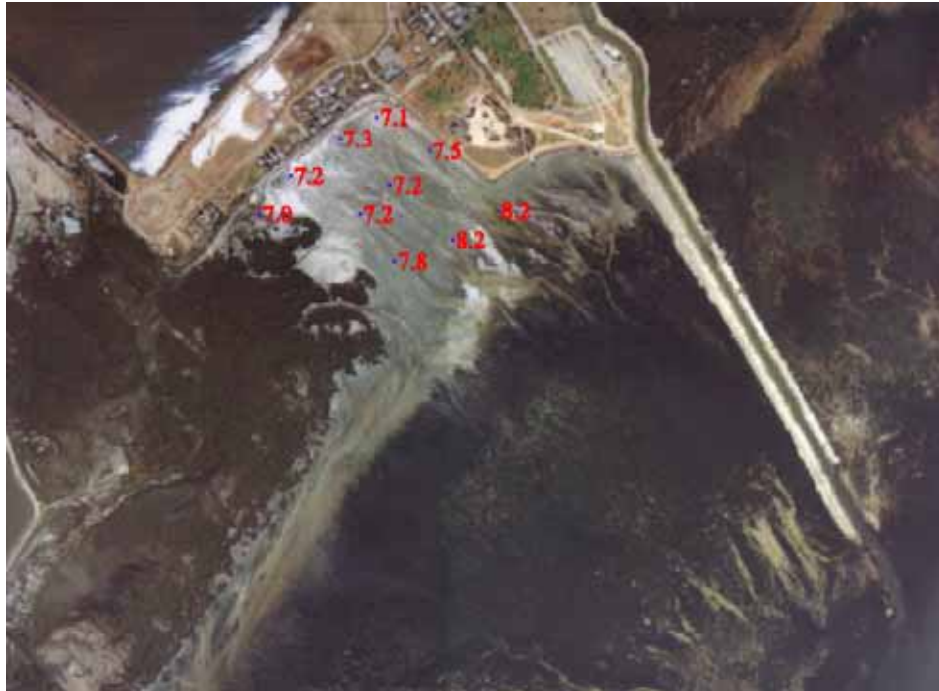
Figure 16 - pH values for interstitial pore water at St Kilda

St Kilda samples had a slightly lower average pH reading (7.4) than the Middle Beach samples (8). The figure below shows the pH readings at St Kilda.

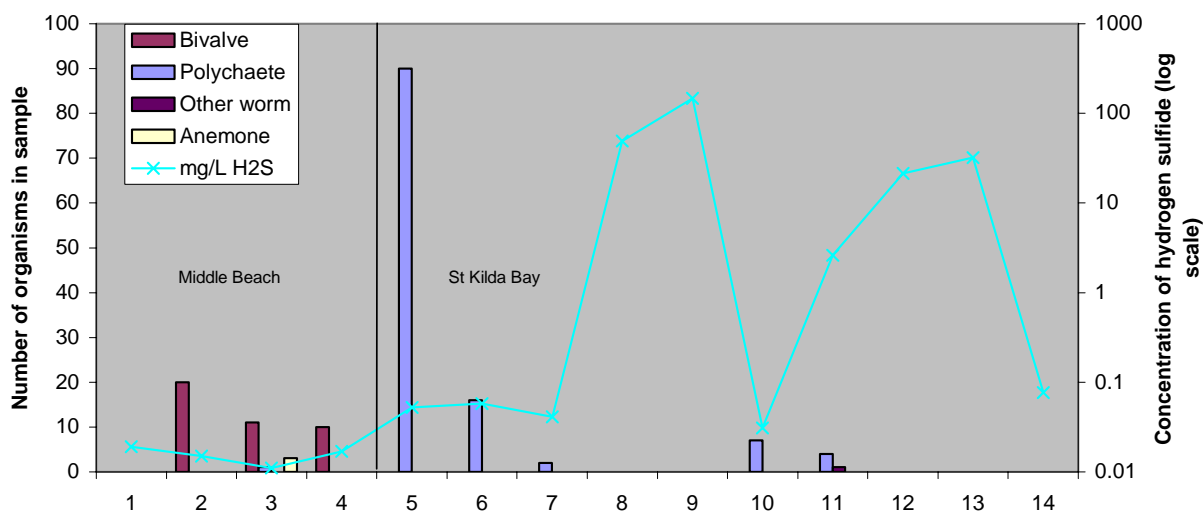
Figure 19 - Benthic organisms vs hydrogen sulfide

Most of the worms at St Kilda were found on the sites that had the lowest hydrogen sulfide readings as can be seen in Figures 17 and 18. Sites with very high sulfide readings contained no visible organisms at all in the samples, although they would have contained bacteria.

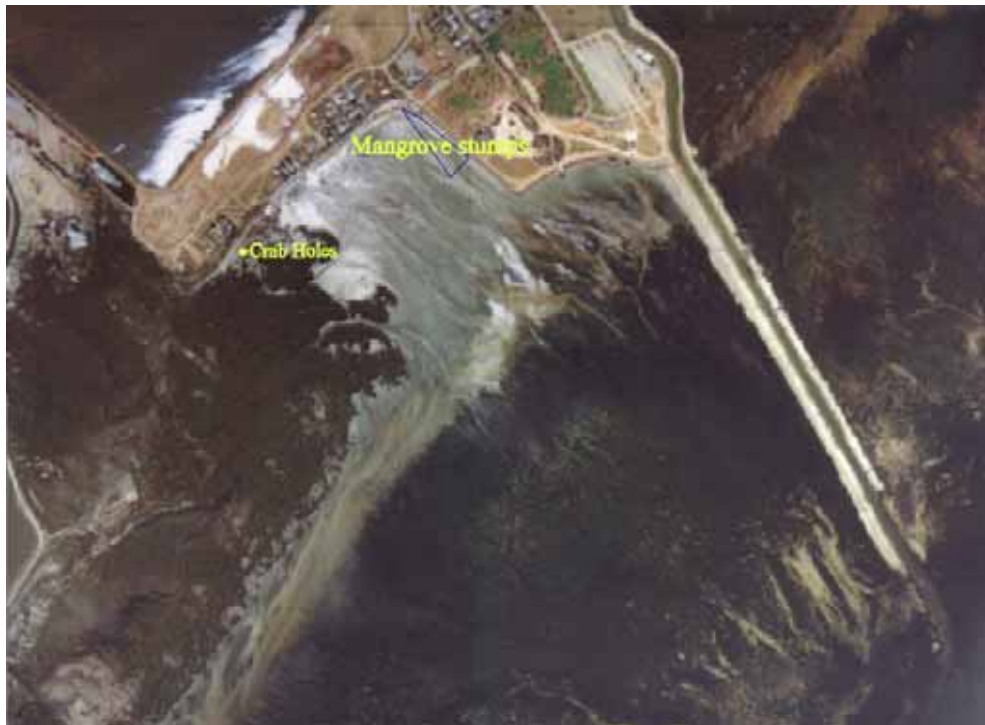
Figure 22 - Observations at St Kilda

Location 15 is shown on the aerial photograph (Figure 22 below) just adjacent to the annotation 'crab holes'. The illustration also contains an observation of where stumps from old mangrove trees were found next to the playground.

At St Kilda only one location had live snails on the surface (there were empty shells right across the beach). The site with live snails was location 15, in the higher littoral zone where the saltmarsh reaches the beach. The snails there were *Salinator fragilis*. Occasional crab holes are also visible at that site, but at nowhere near the density observed at Middle Beach.

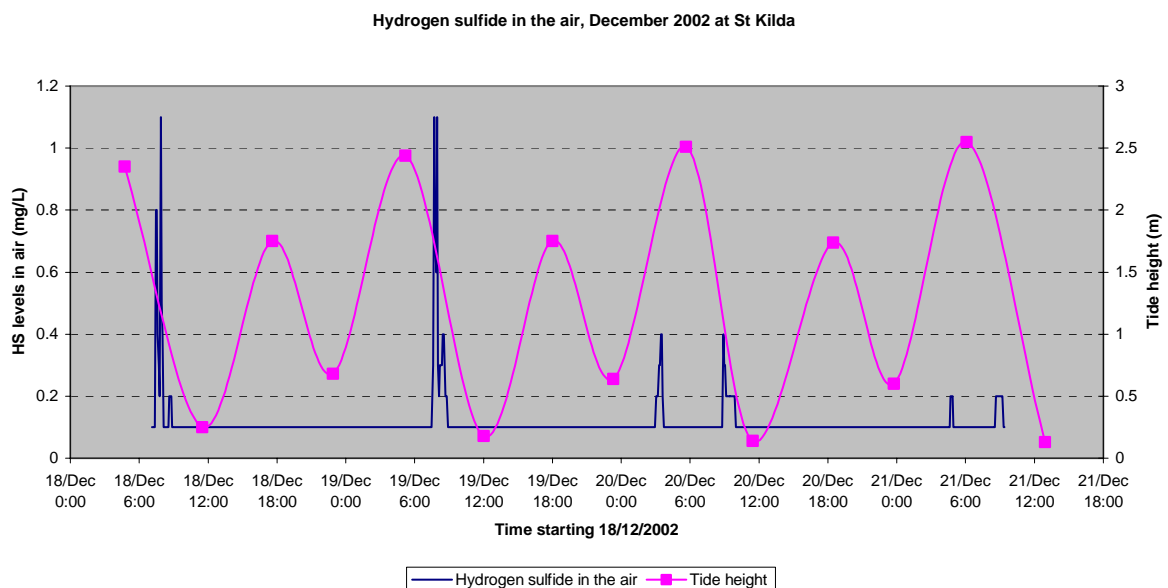
Figure 24 - Tides and hydrogen sulfide in the air, St Kilda 2002

Hydrogen sulfide (H_2S) is a soluble gas, but it will only remain dissolved in water if the water is quite cold. A frequent odour pattern appears when the overnight tidewater is infused with H_2S from the interstitial waters. In the morning, as the tide retreats, the shallow tidewater remaining warms in the morning sun and rapidly loses much of its H_2S to the atmosphere, causing the characteristic smell.

The odour has been observed by many to 'disappear' after a while, and the use of air quality monitoring data loggers in December 2002 confirmed that bad air quality does indeed come in specific events. When the 'bad beach' smell is detectable, hydrogen sulfide levels in the air are above 0.1 part per million. Events monitored over a four-day period reached a peak of 1.1 mg/L. The events that were monitored lasted up to two hours at a time.

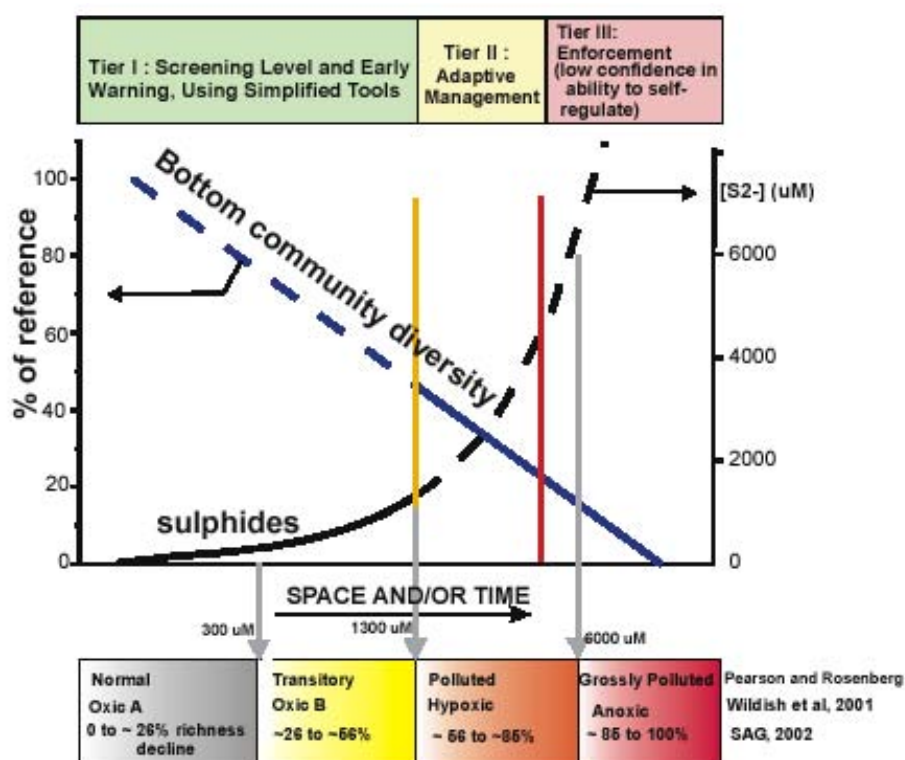
Figure 25 - Relationship between increasing sulfide and decreasing biodiversity (Bright *et al*, 2002)

The ecotoxicology studies confirm that hydrogen sulfide is toxic to many benthic macroinvertebrates. Recent draft legislation on industrial wastes in British Columbia seeks to address the sulfide pollution that happens underneath aquaculture finfish pens. The researchers in British Columbia determined that there was a negative relationship between sulfide levels and biodiversity (Bright *et al*, 2002).

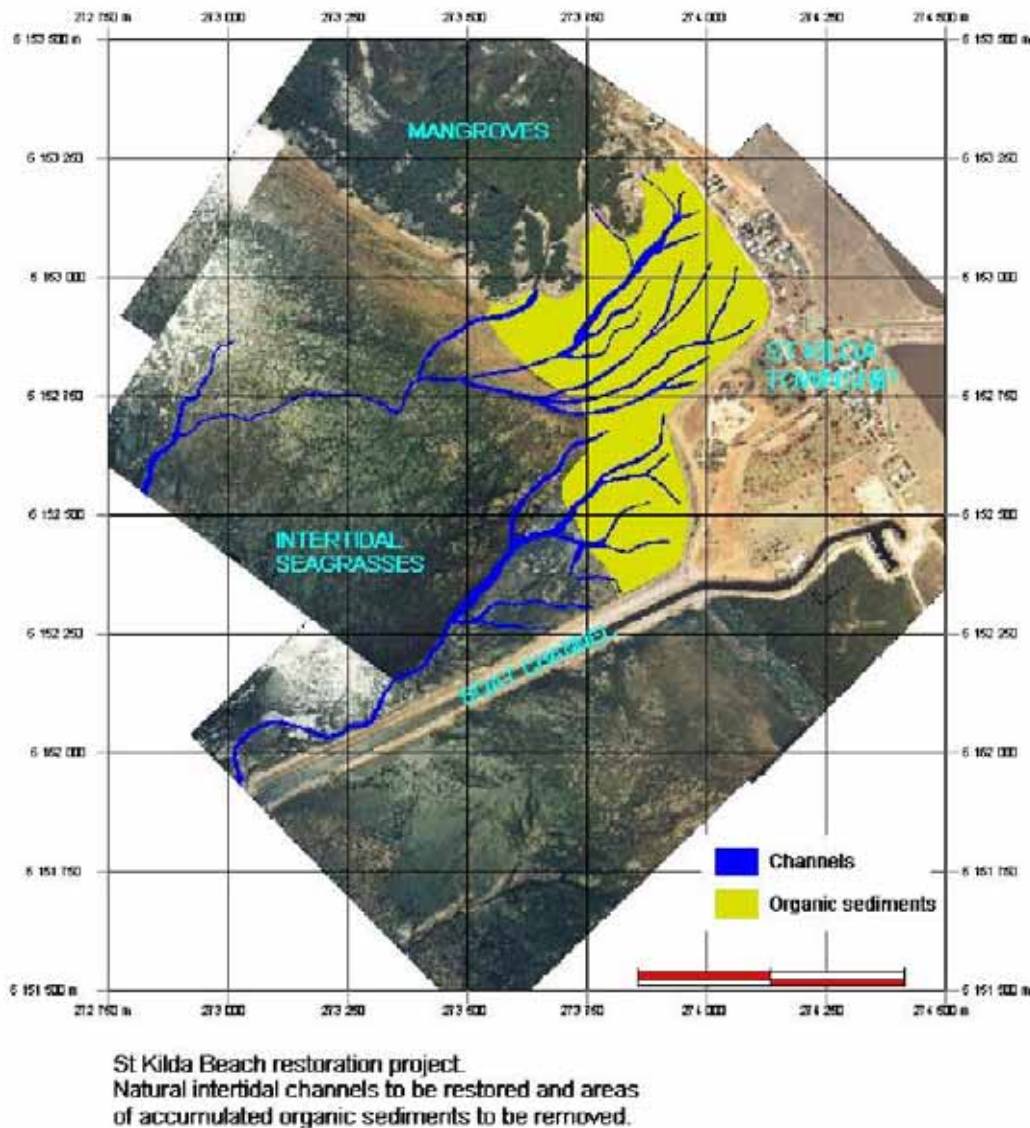
Figure 27 - Restoring historic drainage channels at St Kilda (Blackburn, 2001)

An illustration of the works that would be required to undertake this scenario is provided in the following figure.

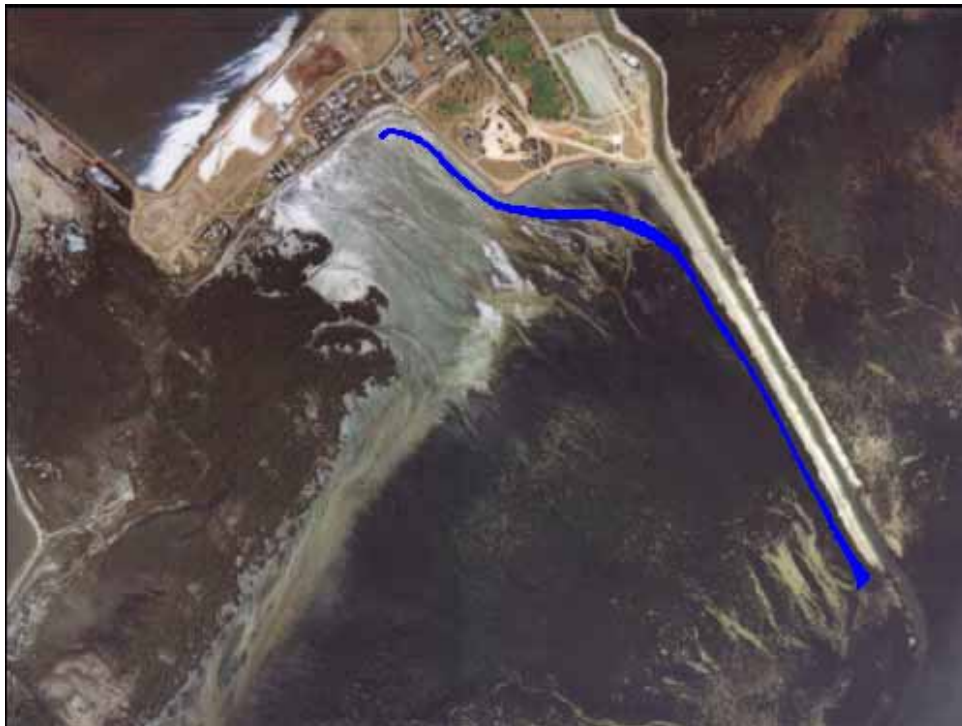
Figure 28 - Single channel proposal

The material won from such a channel may be quite sandy, as studies undertaken for this report have revealed that the area of the bay nearest the playground is not currently covered by deep sediments. If the material is sandy, it could be placed adjacent to the seawall in two locations – the corner next to the boat channel where a small beach exists currently and in front of the rock wall along Beach Road and Whiting Street.

Approximately **13,000 m³ of material** would need to be removed, to form a channel 3m wide at its narrowest and 50cm deep. The channel would be wider where it traverses the tidal flat adjacent to the playground.

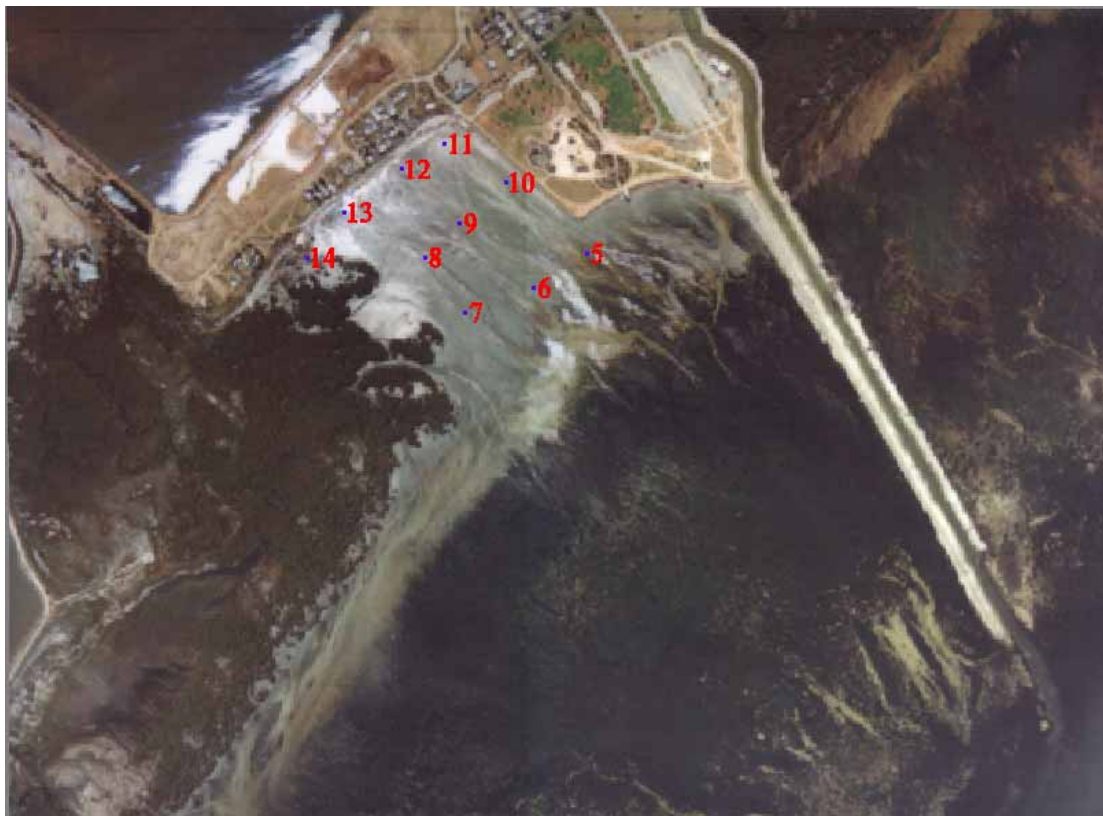
Appendix 1 – Sampling locations in St Kilda Bay – GIS

Township	Sample ID	Easting	Northing
St Kilda	5	273835	6152697
St Kilda	6	273767	6152805
St Kilda	7	273718	6152944
St Kilda	8	273831	6153024
St Kilda	9	273899	6152953
St Kilda	10	273980	6152859
St Kilda	11	274060	6152981
St Kilda	12	274010	6153069
St Kilda	13	273924	6153187
St Kilda	14	273834	6153263
