Lake Indawarra

Concept and Vegetation Plan

Faith Cook and Peri Coleman

17 June 2009

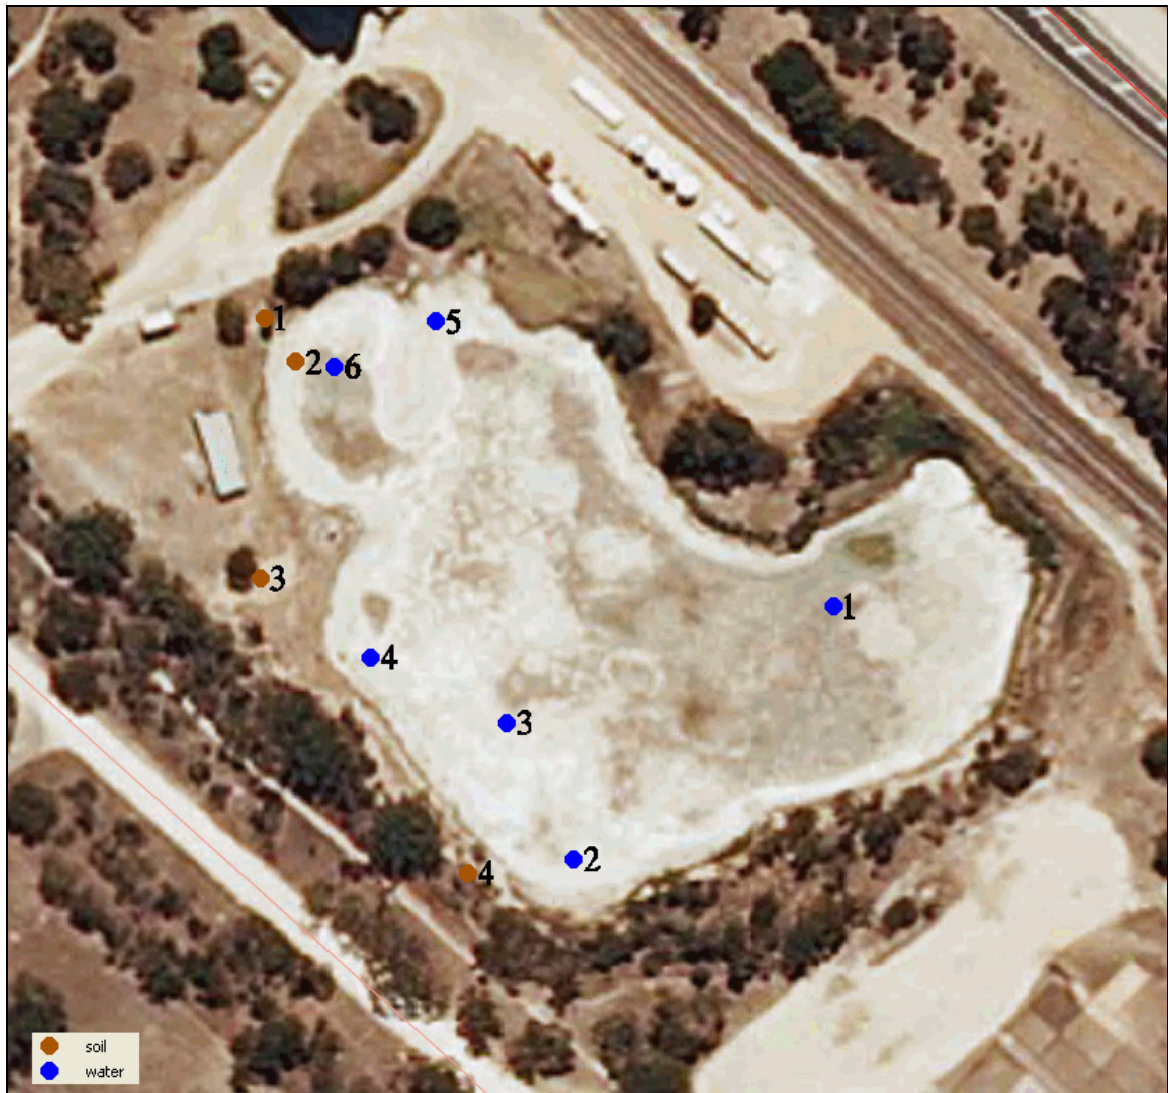
Figure 2 – Soil and water sample locations

Samples of soil were collected from four locations around the lake. The geographic locations are recorded in *Table 1* and are also represented graphically in *Figure 2 – Sample Locations*.

The samples below were taken during the December 2008 field visit, at the water sample locations shown in Figure 2.

During the March 2009 field visit, samples were taken to identify the presence of an algae bloom at Site 6 (clean) and half-way between Site 1 & 2 (bloom). These were tested for pH (using strips) in the field to see if the bloom had caused a difference in water alkalinity. A difference of 1 pH unit was noted, with the coloured water sample having a pH of approximately 9, and clear sample having a pH of approximately 10.

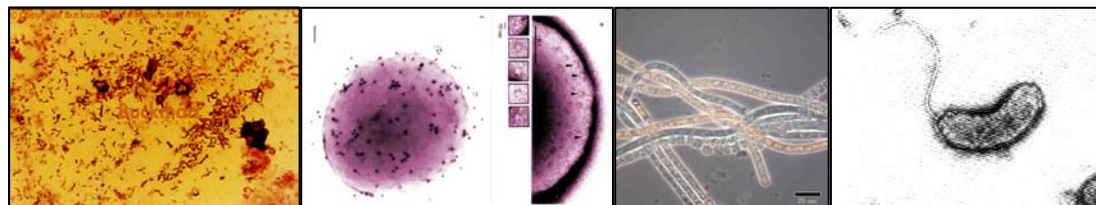
Figure 3 - Desulfobibrio, purple bacteria, Beggiatoa and Thiobacillus (L-R)

There are four main bacterial groups responsible for the sulfur cycle in Lake Indawarra:

- *Thiobacillus* is an incredibly small bacterium that oxidizes S (from Fe-S deposits, other metal sulfides and elemental S) while extracting nitrogen from decomposing organics such as broken down stoneworts and waste grain, making sulfuric acid as a by-product.

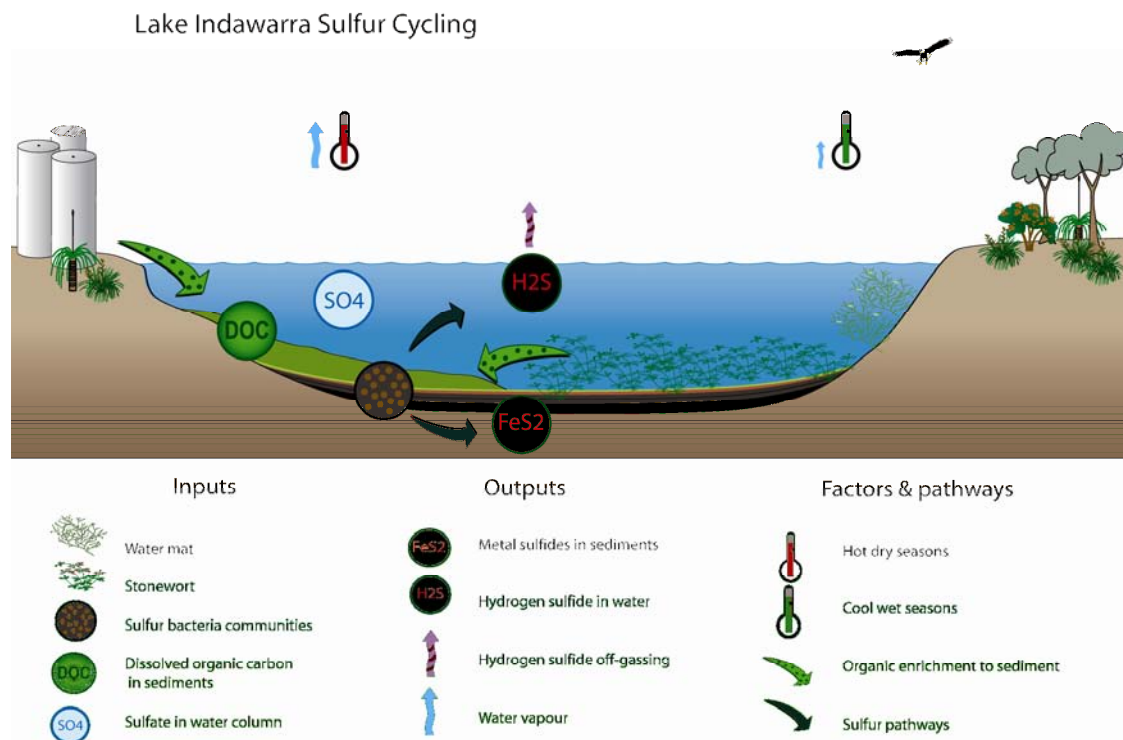
Figure 4 - Conceptual diagram of sulfur cycle in Lake Indawarra (symbols for diagram courtesy of the Integration and Application Network, University of Maryland Center for Environmental Science)

In Lake Indawarra, the sulfur cycle (Figure 4) is driven by several different factors. The available sulfate comes from the groundwater. The organics are supplied by the breakdown of stoneworts when the water becomes hot or too saline, and possibly by grain dust or grain wastes.

While some sulfate reduction in the lake is inevitable, it possibly may be slowed down. The supply of SO_4 from the groundwater is a factor that cannot be controlled, however the quantity of organic sediment and muddy sediment that can host the bacteria, water temperature and water oxygenation may all be modified.

Actions to reduce the quantity of sulfate reduction include ensuring no waste grain or by-products enter the lake, ensuring the lake is maintained at a reasonable depth to allow water temperatures to stay low and reduce the evaporation effects on salinity (maintaining the health of the stoneworts), removal of as much 'soft bottom' as possible to reduce areas where anoxic sulfate reducing bacteria can establish large colonies, and maintenance of water movement by bubblers or paddlewheels to ensure oxygenation is maintained.

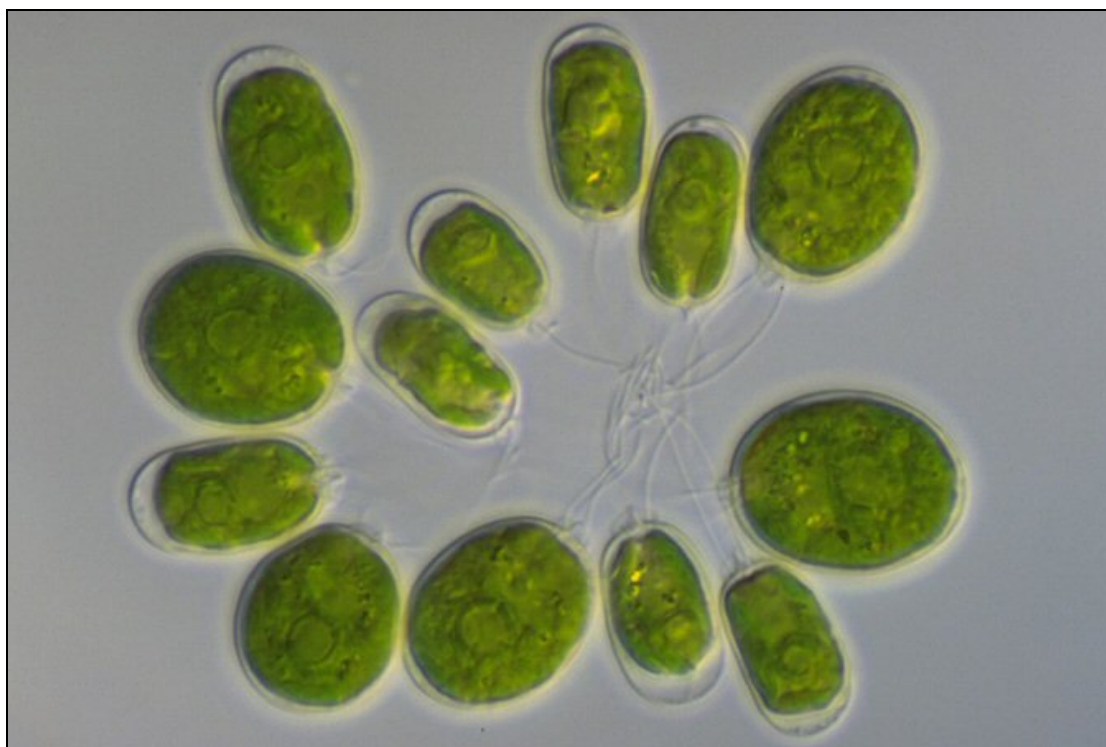
Figure 5 - Chlorophycean bloom of *Carteria* sp.

On the field visit in March 2009, the water of the lake (mainly near the undredged section on the south-eastern side) was discoloured by a bloom of microalgae. The bloom was *Carteria* sp., a unicellular green algae distinguished from similar genera by the presence of four flagella (Figure 5). The algae has been reported as "bloom-forming" in other Australian lakes during periods of low water levels (eg Lake Wendouree near Ballarat) and is also recorded from estuaries.

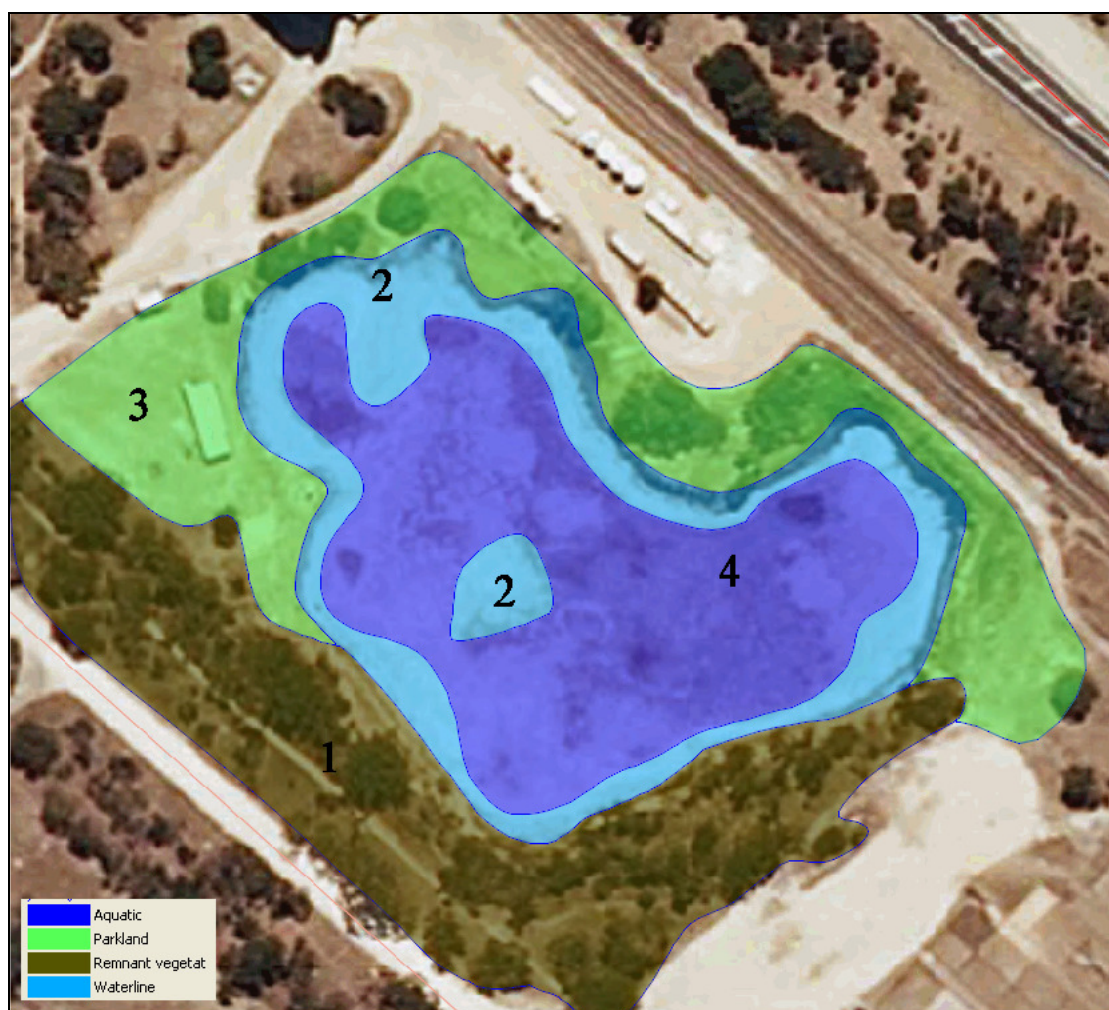
Figure 6 - Vegetation zones

The development of the Lake Indawarra site over time has resulted in four distinct vegetation zones. The eastern and northern areas have been developed for recreational purposes as a park land and these areas support grassed expanses and several plantings of locally exotic trees and shrubs.

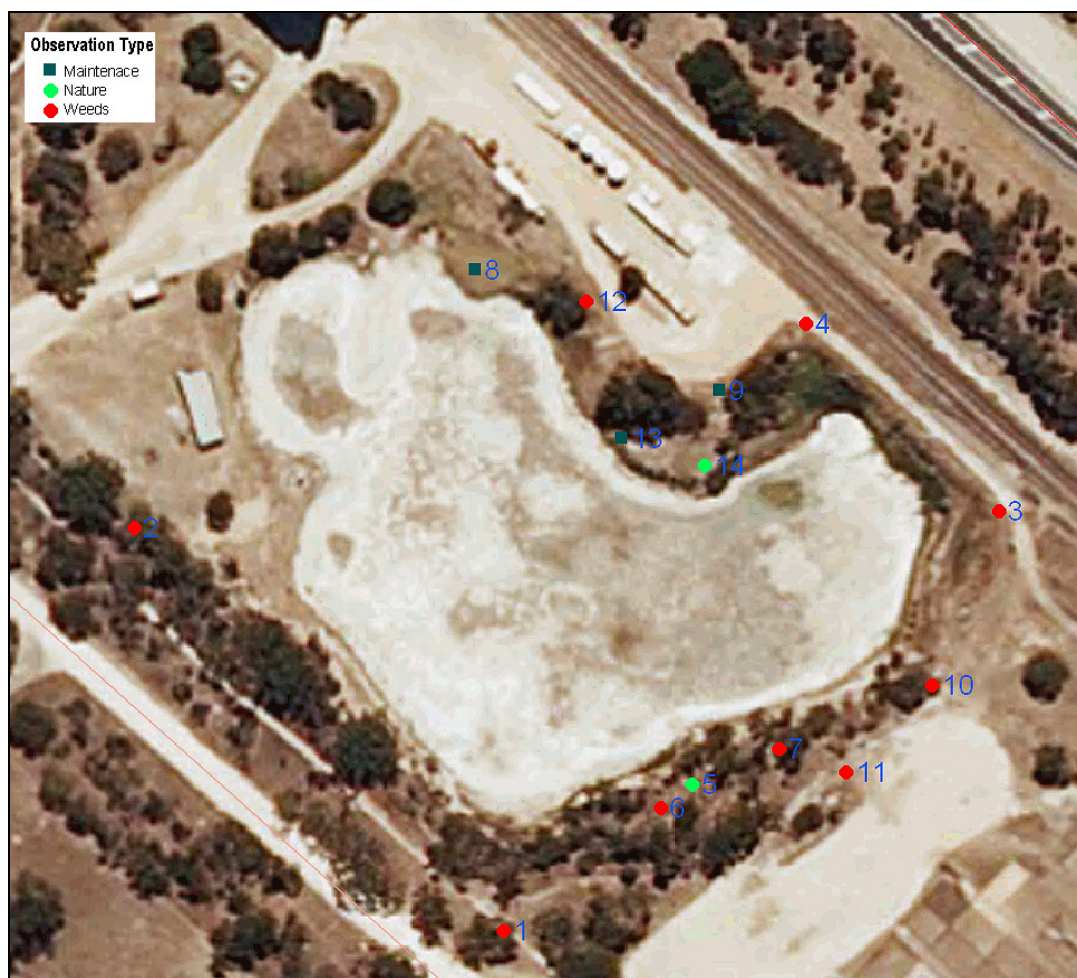
Figure 7 - Observation locations

- Weed observations relate to where weed species were seen, and control of these species at these locations should be undertaken.
- Maintenance observations are where a general maintenance action is required (e.g. removal of rubbish or tending to a lawned area).
- The third type of observation recorded at this site is ‘nature’ which is simply where a single patch of unusual vegetation, form or habitat has been observed and where interpretive signage may be useful in the future.

Figure 4 shows the locations of each observation. The type of observation is shown by the symbol used to display its location.

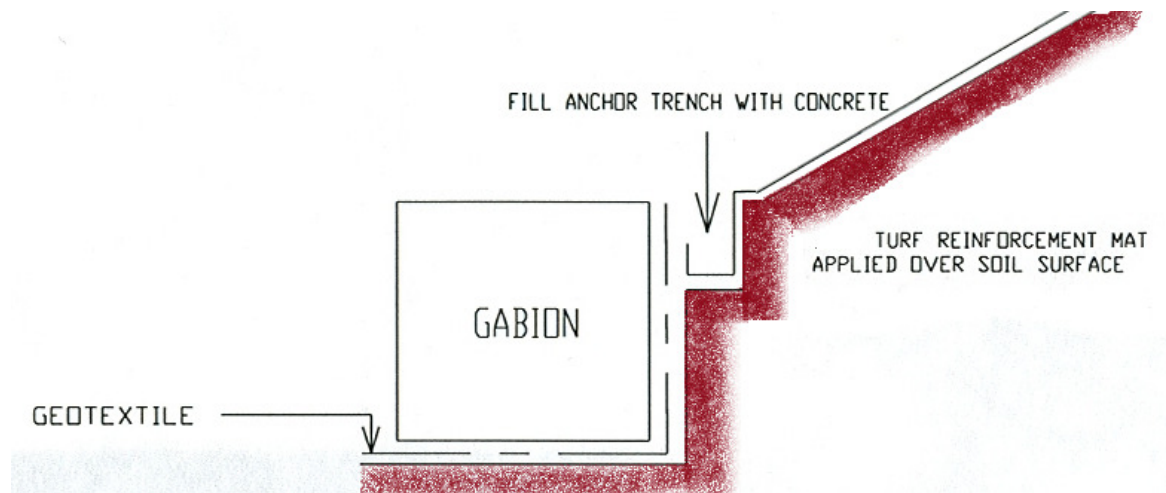
Figure 8 - Use of geotextile & gabions

Due to the high fine sediment content of surrounding soils, it is important that all gabion or retaining structures are separated from the soil they retain by a layer of geotextile. As it will not be subject to heavy vehicle traffic or wave action, a light to medium grade should be sufficient. The diagram below shows best practice installation of geotextiles and gabions to minimise site erosion or slumping.

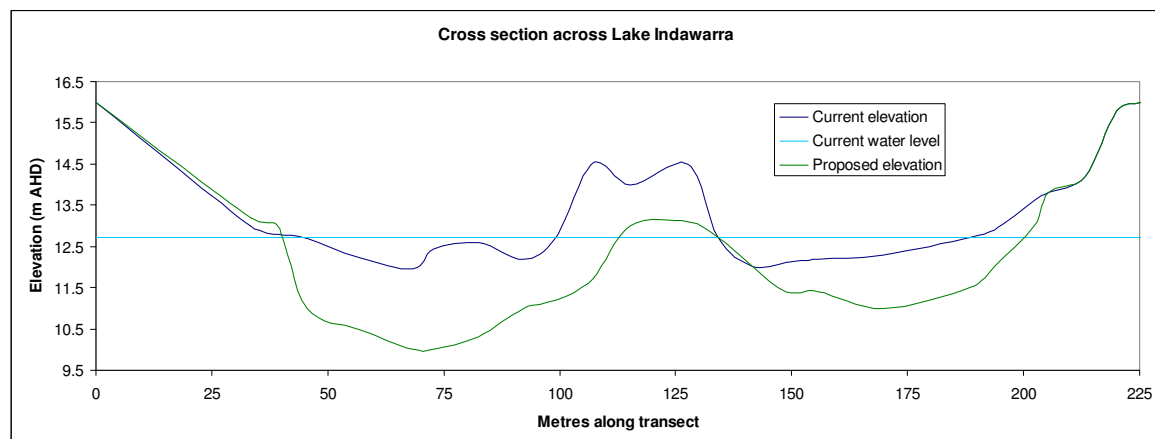
Figure 9 - Cross section of the lake

The chart below shows a cross section of the lake, with the current and proposed elevations, from the corner of the lake nearest the silos, through the most southern corner of the proposed viewing platform.
